# Access Compliance Report

## Public Rights-of-Way

### (Curb Ramps)

| Intersection ID: 49130 | Main Street: AUBURN_HILL_LN | Cross Street: WILTSHIRE_RIDGE_RD | Location: SW |

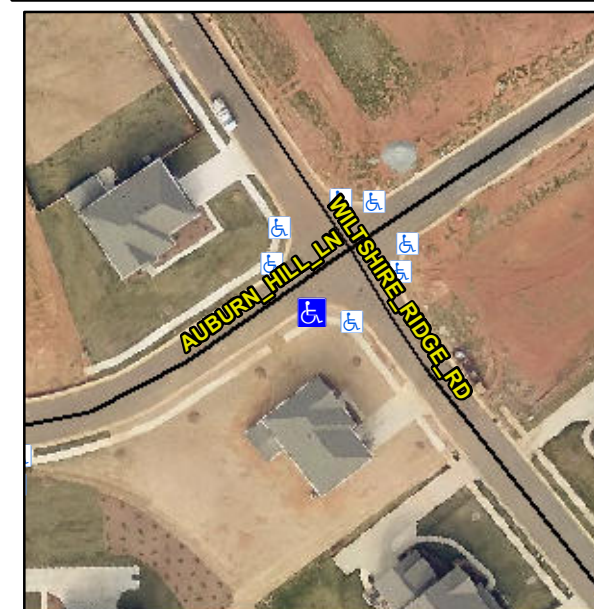
| ADA ID: 00576E8CD71B | Ramp Type: Perp | Initial Pass/Fail: Fail | Overall Compliance: No |
| Severity Score: 8.75 | | | |

**Not Found, R304.5.1**

| Compliance | Description | Data | Compliance | Description | Data |
|---|---|---|---|---|---|
| No | Ramp Width (in) | 47.0 | Yes | Ramp XSlope (%) | 0.2 |

**Remove & Replace Entire Ramp.**
