Access Compliance Report

Public Rights-of-Way (Curb Ramps)

| Intersection ID: N/A | Main Street: MILLENNIUM_AV | Cross Street: CITY_PARK_DR | Location: SE |
| ADA ID: 005E35681147 | Ramp Type: Directional1 | Initial Pass/Fail: Fail | Overall Compliance: No |

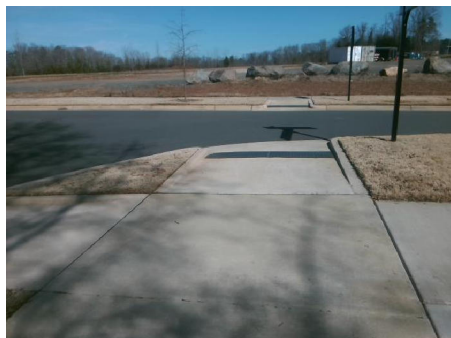
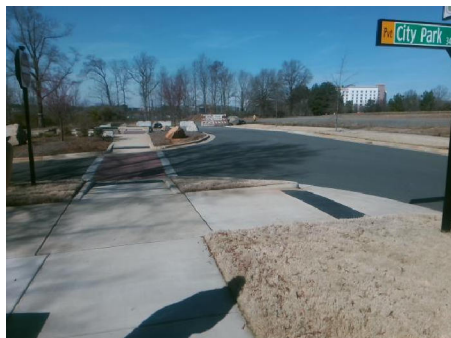
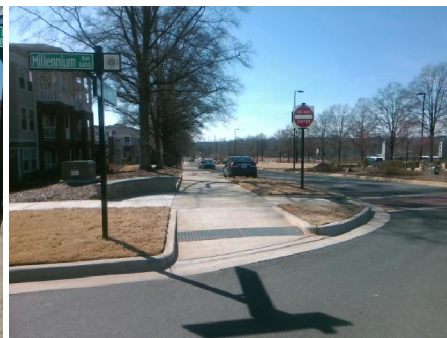
| Compliance | Description | Data | Compliance | Description | Data |
|---|---|---|---|---|---|
| No | Ramp XSlope (%) | 4.9 | | | |

Remove & Replace Entire Ramp.
