Access Compliance Report

Public Rights-of-Way

(Curb Ramps)

| Intersection ID: 7770 | Main Street: E_ARROWHEAD_DR | Cross Street: N_TRYON_ST | Location: SW |

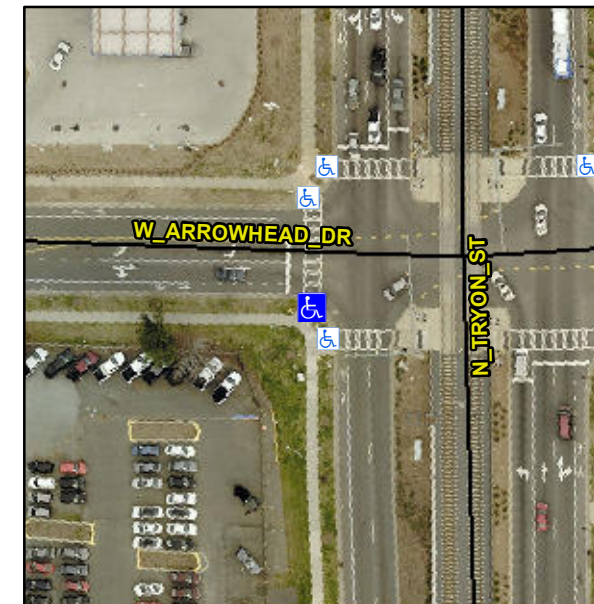
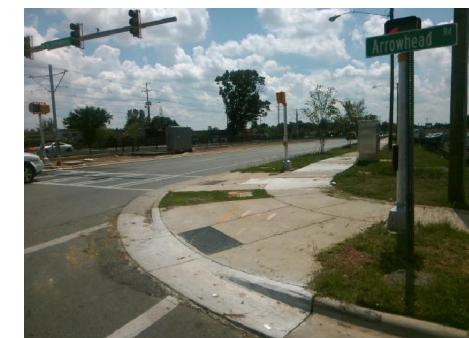
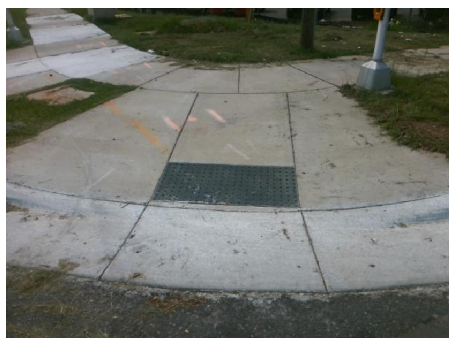
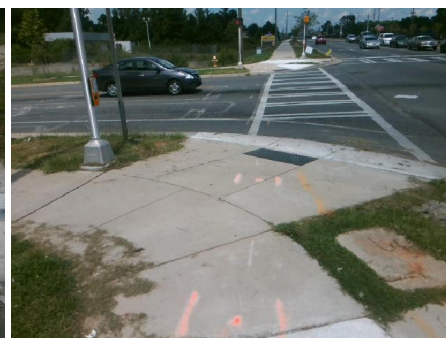
| ADA ID: 0074611FAC44 | Ramp Type: Perp | Initial Pass/Fail: Fail | Overall Compliance: No |
| Severity Score: 10 | | | |

Not Found, R304.5.1

| Compliance | Description | Data | Compliance | Description | Data |
|---|---|---|---|---|---|
| No | Ramp Width (in) | 47.5 | Yes | Ramp XSlope (%) | 2.8 |

Possible Solutions:

Remove & Replace Entire Ramp.
