## **Access Compliance Report Public Rights-of-Way** (Curb Ramps)

Intersection ID: 49313 Main Street: ROCKLAND DR Cross Street: MISTY\_EVE\_LN Location: W **Overall Compliance: No** ADA ID: 0076A737093E Ramp Type: Perp Initial Pass/Fail: Fail **Severity Score:** 10

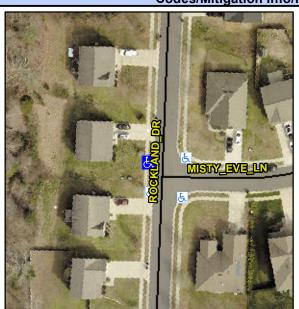
| Field Measurements/Component Compliance | | | | | |
|---|---|---|---|---|---|
| No | Ramp Width (in) | 47.5 | Yes | Ramp XSlope (%) | 2.6 |

**ROCKLAND DR** Street 1 Name Stop Condition-Street 2 None Street 2 Name N/A Stop Condition-Street 1 N/A Possible Solutions: Remove & Replace Entire Ramp. Surveyor Notes: N/A PROW/ADA: Not Found, R304.5.1
