Access Compliance Report

Public Rights-of-Way

(Curb Ramps)

Intersection ID: 49125	Main Street: LEGOLAS_LN	Cross Street: LAVETA_RD	Location: SE
ADA ID: 011DDFC09056	Ramp Type: PerpDiag	Initial Pass/Fail: Fail	Overall Compliance: No
		Severity Score: 8.75

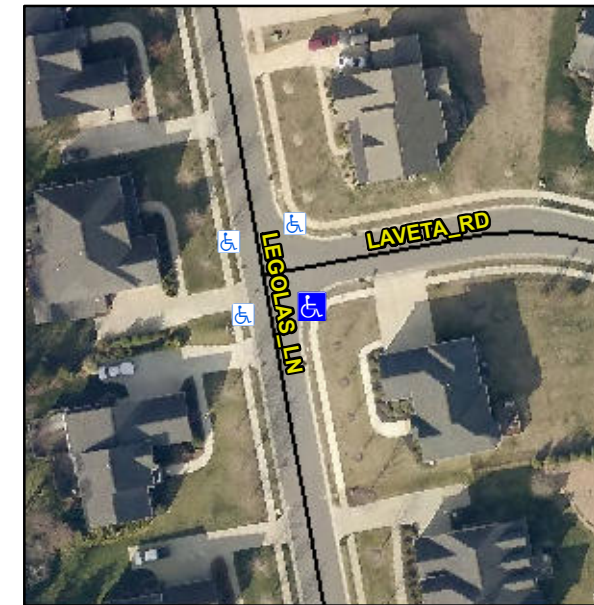
Not Found, R304.5.1

Compliance	Description	Data	Compliance	Description	Data
N/A	Ramp Length (in)	47.0	Yes	Ramp Slope (%)	7.1
No	Ramp Width (in)	45.0	Yes	Ramp XSlope (%)	1.7
N/A	Flare Type LT	N/A	N/A	Flare Type RT	N/A
N/A	Flare Slope LT (%)	N/A	N/A	Flare Slope RT (%)	N/A
N/A	Flare Traversable LT?	N/A	N/A	Flare Traversable RT?	N/A
N/A	Landing Length (in)	N/A	N/A	DWS Provided?	N/A
N/A	Landing Width (in)	N/A	N/A	DWS Contrast?	N/A
N/A	Landing Slope (%)	N/A	N/A	DWS Length (in)	N/A
N/A	Landing X Slope (%)	N/A	N/A	DWS Full Width?	N/A
N/A	Landing Curb? (Y/N)	N/A	N/A	DWS Offset (in)	N/A
N/A	Shared Landing?	N/A			
N/A	Gutter Ponding?	N/A	N/A	Gutter Slope (%)	N/A
N/A	Gutter Lip Ht (in)	N/A	N/A	Gutter X Slope (%)	N/A
N/A	Painted X Walk1?	No	N/A	Painted X Walk2?	No
	X Walk 1 Direction	To N		X Walk 2 Direction	To W
N/A	X Walk 1 Width (in)	N/A	N/A	X Walk 2 Width (in)	N/A
	X Walk 1 Slope (%)	3.1		X Walk 2 Slope (%)	1.2
	X Walk 1 X Slope (%)	0.9		X Walk 2 X Slope (%)	3.2

Remove & Replace Curb Ramp With Two New Directional Ramps or Equivalent.
