Access Compliance Report

Public Rights-of-Way

(Curb Ramps)

| Intersection ID: 53899 | Main Street: LANGWELL_LN | Cross Street: ELGIN_MOOR_RD | Location: SW |

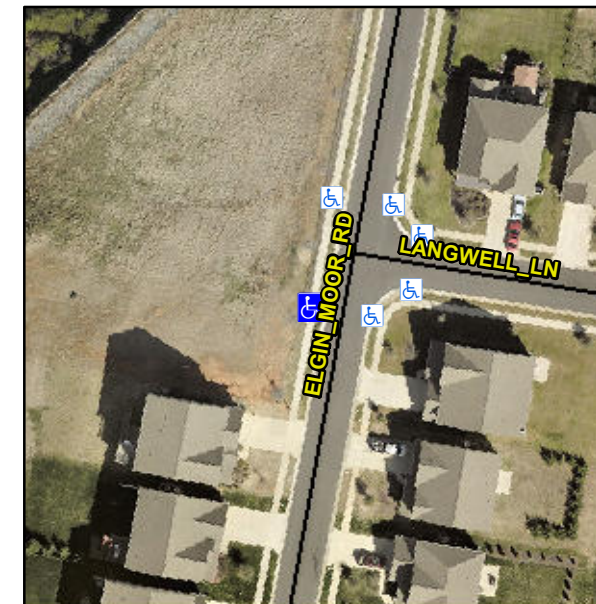
| ADA ID: 01219417177B | Ramp Type: Perp | Initial Pass/Fail: Fail | Overall Compliance: No |
| Severity Score: 21.25 | | | |

Not Found, R304.5.1, R304.5.3

| Compliance | Description | Data | Compliance | Description | Data |
|---|---|---|---|---|---|
| No | Ramp Width (in) | 47.5 | No | Ramp XSlope (%) | 6.0 |

Possible Solutions:

Remove & Replace Entire Ramp.
