# Access Compliance Report

## Public Rights-of-Way

### (Curb Ramps)

| Intersection ID: 12248 | Main Street: E_8TH_ST | Cross Street: N_BREVARD_ST | Location: W |

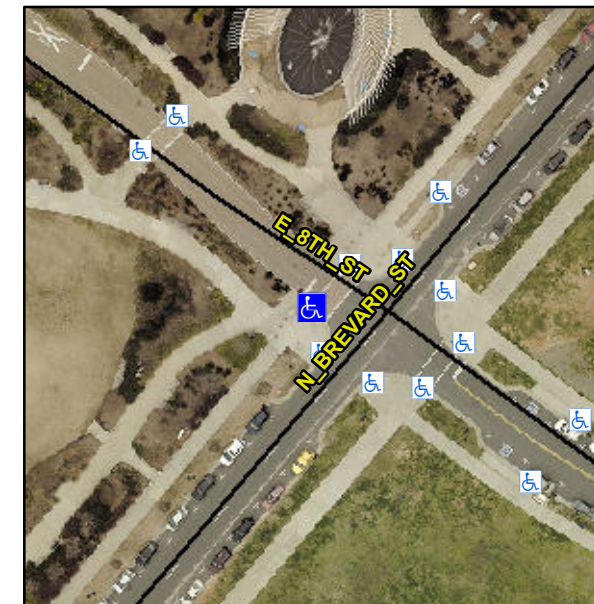
| ADA ID: 016353F220BB | Ramp Type: Perp | Initial Pass/Fail: Fail | Overall Compliance: No |

**SLOPE VERIFIED & MATCHED.**

**Not Found, R304.5.1, R304.2.2**

| Compliance | Description | Data | Compliance | Description | Data |
|---|---|---|---|---|---|
| N/A | Ramp Length (in) | 72.0 | No | Ramp Slope (%) | 9.4 |
| No | Ramp Width (in) | 35.0 | Yes | Ramp XSlope (%) | 1.2 |

**Remove & Replace Entire Ramp.**
