## Access Compliance Report Public Rights-of-Way (Curb Ramps)

Intersection ID: 14373 Main Street: EAST\_BV Cross Street: LYNDHURST\_AV Location: SW

ADA ID: 01668E901EFF Ramp Type: Perp Initial Pass/Fail: Fail Overall Compliance: No Severity Score: 12.5

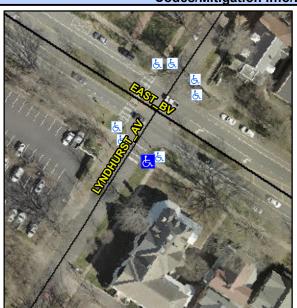
Not Found, R304.2.2

| Field Measurements/Component Compliance | | | | | |
|---|---|---|---|---|---|
| N/A | Ramp Length (in) | 67.5 | No | Ramp Slope (%) | 9.2 |

Remove & Replace Entire Ramp.
