# Access Compliance Report

## Public Rights-of-Way

| Intersection ID: 6039 | Main Street: DELLINGER_DR | Cross Street: MILHAVEN_LN | Location: NE |
| ADA ID: 017334E07DB7 | Ramp Type: PerpDiag | Initial Pass/Fail: Pass | Overall Compliance: No |

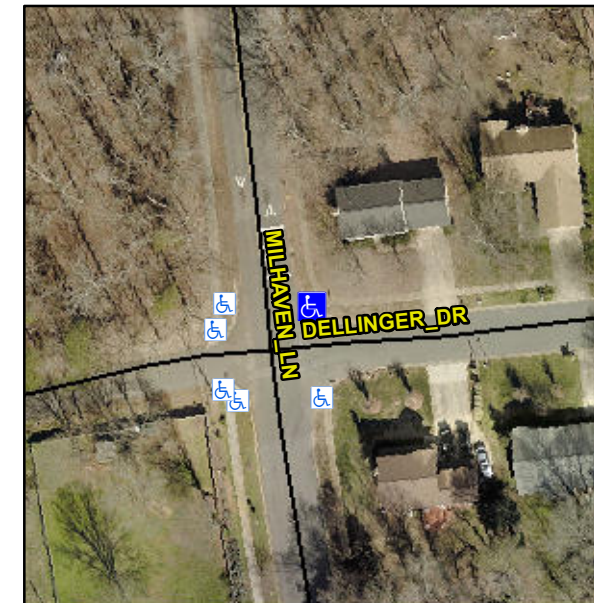
**Not Found, R304.5.3, R304.2.2-Perp, R304.3.2-Para, R305.2, R302.7.2, R304.5.4**

| Compliance | Description | Data | Compliance | Description | Data |
|---|---|---|---|---|---|
| Yes | Ramp Width (in) | 48.0 | No | Ramp XSlope (%) | 3.7 |
| No | Landing Slope (%) | 4.9 | Yes | DWS Length (in) | 24.0 |
| No | Landing X Slope (%) | 8.2 | Yes | DWS Full Width? | Yes |
| N/A | Landing Curb? (Y/N) | No | No | DWS Offset (in) | 4.5 |
| Yes | Gutter Ponding? | No | No | Gutter Slope (%) | 6.4 |
| No | Gutter Lip Ht (in) | 0.5 | No | Gutter X Slope (%) | 5.6 |

**Remove & Replace Curb Ramp With Two New Directional Ramps or Equivalent. Remove & Replace Gutter.**
