Access Compliance Report

Public Rights-of-Way

(Curb Ramps)

Intersection ID: 11049	Main Street: MALTA_PL	Cross Street: OAK_FOREST_DR	Location: SE
ADA ID: 0176F0926BDD	Ramp Type: Perp	Initial Pass/Fail: Fail	Overall Compliance: No
Severity Score: 8.75			
Codes/Mitigation Info/Possible Solution		Field Measurements/Component Compliance

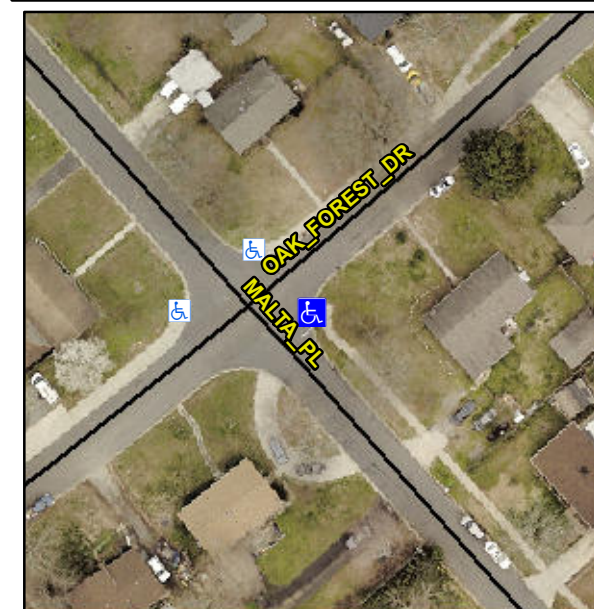
Not Found, R304.5.1

Compliance	Description	Data	Compliance	Description	Data
N/A	Ramp Length (in)	47.0	Yes	Ramp Slope (%)	5.0
No	Ramp Width (in)	45.5	Yes	Ramp XSlope (%)	0.2
N/A	Flare Type LT	N/A	N/A	Flare Type RT	N/A
N/A	Flare Slope LT (%)	N/A	N/A	Flare Slope RT (%)	N/A
N/A	Flare Traversable LT?	N/A	N/A	Flare Traversable RT?	N/A
N/A	Landing Length (in)	N/A	N/A	DWS Provided?	N/A
N/A	Landing Width (in)	N/A	N/A	DWS Contrast?	N/A
N/A	Landing Slope (%)	N/A	N/A	DWS Length (in)	N/A
N/A	Landing X Slope (%)	N/A	N/A	DWS Full Width?	N/A
N/A	Landing Curb? (Y/N)	N/A	N/A	DWS Offset (in)	N/A
N/A	Shared Landing?	N/A			
N/A	Gutter Ponding?	N/A	N/A	Gutter Slope (%)	N/A
N/A	Gutter Lip Ht (in)	N/A	N/A	Gutter X Slope (%)	N/A
N/A	Painted X Walk1?	No	N/A	Painted X Walk2?	N/A
	X Walk 1 Direction	To NW		X Walk 2 Direction	N/A
N/A	X Walk 1 Width (in)	N/A	N/A	X Walk 2 Width (in)	N/A
	X Walk 1 Slope (%)	1.4		X Walk 2 Slope (%)	N/A
	X Walk 1 X Slope (%)	2.3		X Walk 2 X Slope (%)	N/A

Remove & Replace Entire Ramp.

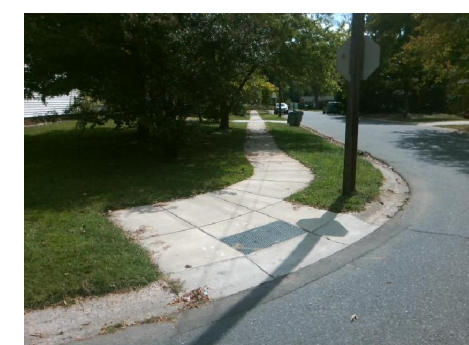
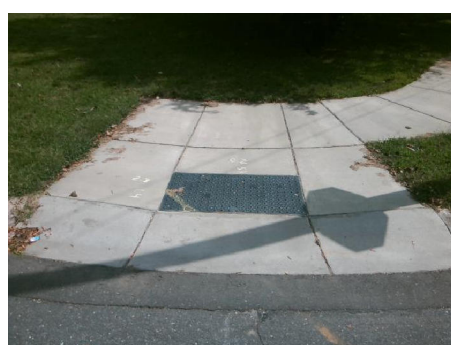
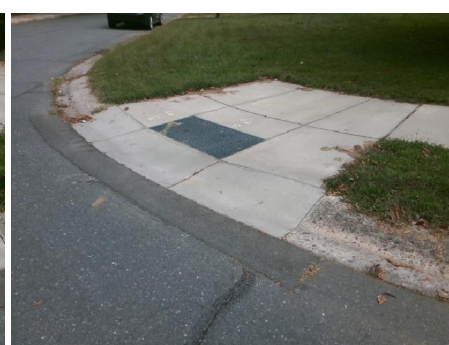
N/A	Ramp inside XWalk1?	N/A	N/A	Ramp inside XWalk2?	N/A
	Road Slope (%)	N/A	N/A	Clear Space?	N/A
	Road X Slope (%)	N/A	N/A	Clear Space to XWalk (in)	N/A
N/A	Any Obstructions?	N/A	N/A	Storm Grate/Utility Hazard?	N/A
	Obstruction Type			Storm Grate/Utility Type	
		N/A			N/A
			Yes	Surface Condition? (G/P)	Good
