# Access Compliance Report

## Public Rights-of-Way

### (Curb Ramps)

| Intersection ID: 50606 | Main Street: DENBUR_DR | Cross Street: BENDING_BRANCH_RD | Location: E |

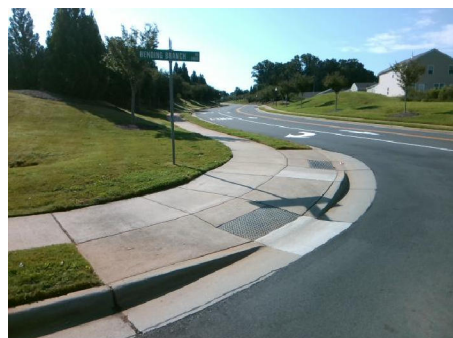
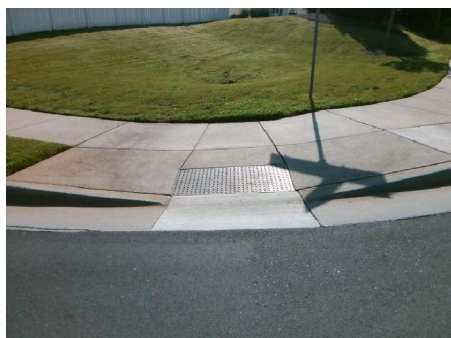
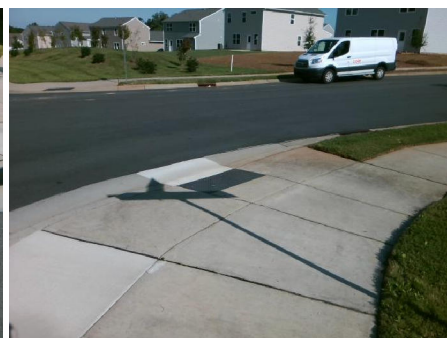
**Not Found, R304.5.1, R304.2.2, R304.5.3**

| Compliance | Description | Data | Compliance | Description | Data |
|---|---|---|---|---|---|
| N/A | Ramp Length (in) | 47.5 | No | Ramp Slope (%) | 9.3 |
| No | Ramp Width (in) | 41.0 | No | Ramp XSlope (%) | 5.2 |

**Remove & Replace Entire Ramp.**
