## Access Compliance Report Public Rights-of-Way (Curb Ramps)

Intersection ID: 19169Main Street:LIVINGSTON\_DRCross Street: SARDIS\_RDLocation:NWADA ID: 01C49156C9AARamp Type:PerpInitial Pass/Fail:FailOverall Compliance: NoSeverity Score:13.75

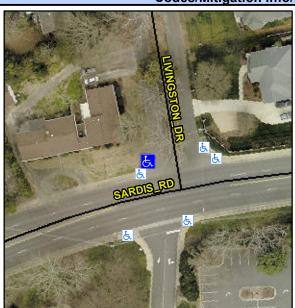
Possible Solutions:	9
Remove & Replace Entire Ramp.	
•	Υ
	N
	N
	1
	1
Surveyor Notes:	1
N/A	1
	1
	1
	1
PROW/ADA:	1
Not Found, R304.2.2, R304.5.3	N
	ı
	N
	N

Field Measurements/Component Compliance							
Comp	liance Description	Data	Comp	liance Description	Data		
N/A	Ramp Length (in)	59.0	No	Ramp Slope (%)	11.6		
Yes	Ramp Width (in)	48.0	No	Ramp XSlope (%)	2.3		
N/A	Flare Type LT	N/A	N/A	Flare Type RT	N/A		
N/A	Flare Slope LT (%)	N/A	N/A	Flare Slope RT (%)	N/A		
N/A	Flare Traversable LT?	N/A	N/A	Flare Traversable RT?	N/A		
N/A	Landing Length (in)	N/A	N/A	DWS Provided?	N/A		
N/A	Landing Width (in)	N/A	N/A	DWS Contrast?	N/A		
N/A	Landing Slope (%)	N/A	N/A	DWS Length (in)	N/A		
N/A	Landing X Slope (%)	N/A	N/A	DWS Full Width?	N/A		
N/A	Landing Curb? (Y/N)	N/A	N/A	DWS Offset (in)	N/A		
N/A	Shared Landing?	N/A					
N/A	Gutter Ponding?	N/A	N/A	Gutter Slope (%)	N/A		
N/A	Gutter Lip Ht (in)	N/A	N/A	Gutter X Slope (%)	N/A		
N/A	Painted X Walk1?	No	N/A	Painted X Walk2?	N/A		
	X Walk 1 Direction	То Е		X Walk 2 Direction	N/A		
N/A	X Walk 1 Width (in)	N/A	N/A	X Walk 2 Width (in)	N/A
