# Access Compliance Report

## Public Rights-of-Way

### (Curb Ramps)

Intersection ID: N/A	Main Street: FLYING_SCOTSMAN_DR	Cross Street: ROCKET_LN	Location: NW
ADA ID: 01D8E79509E9	Ramp Type: Combination2Diag	Initial Pass/Fail: Fail	Overall Compliance: No
		Severity Score: 0

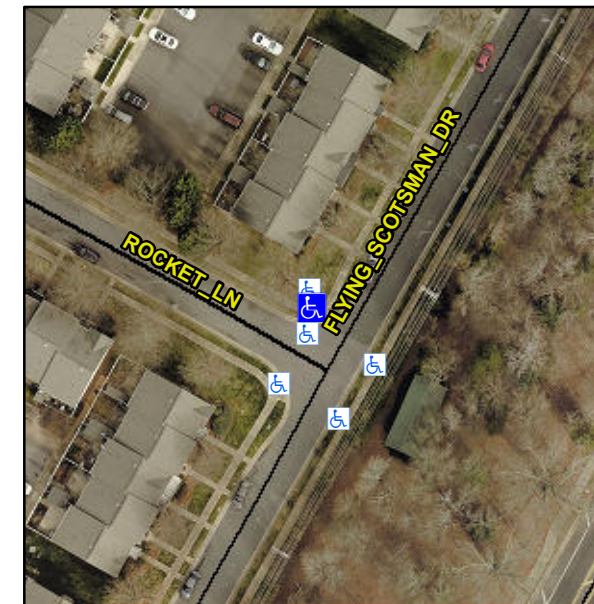
**Not Found, R304.5.1, R304.5.1, R304.2.2, R304.5.3**

Compliance	Description	Data	Compliance	Description	Data
N/A	Ramp Length LT (in)	N/A	N/A	Ramp Length RT (in)	42.5
N/A	Ramp Width LT (in)	N/A	No	Ramp Width RT (in)	44.0
N/A	Ramp Slope LT (%)	N/A	Yes	Ramp Slope RT (%)	7.5
N/A	Ramp XSlope LT (%)	N/A	Yes	Ramp XSlope RT (%)	1.4
N/A	Ramp Length (in)	48.0	No	Ramp Slope (%)	8.4
No	Ramp Width (in)	41.0	No	Ramp XSlope (%)	4.1
N/A	Flare Type LT	N/A	N/A	Flare Type RT	N/A
N/A	Flare Slope LT (%)	N/A	N/A	Flare Slope RT (%)	N/A
N/A	Flare Traversable LT?	N/A	N/A	Flare Traversable RT?	N/A
N/A	Landing Length (in)	N/A	N/A	DWS Provided?	N/A
N/A	Landing Width (in)	N/A	N/A	DWS Contrast?	N/A
N/A	Landing Slope (%)	N/A	N/A	DWS Length (in)	N/A
N/A	Landing X Slope (%)	N/A	N/A	DWS Full Width?	N/A
N/A	Landing Curb? (Y/N)	N/A	N/A	DWS Offset (in)	N/A
N/A	Shared Landing?	N/A			
N/A	Gutter Ponding?	N/A	N/A	Gutter Slope (%)	N/A
N/A	Gutter Lip Ht (in)	N/A	N/A	Gutter X Slope (%)	N/A
N/A	Painted X Walk1?	No	N/A	Painted X Walk2?	No

X Walk 1 Direction	To SW		X Walk 2 Direction	To SE
	X Walk 1 Width (in)	N/A		X Walk 2 Width (in)	N/A
	X Walk 1 Slope (%)	2.4		X Walk 2 Slope (%)	6.0
	X Walk 1 X Slope (%)	5.5		X Walk 2 X Slope (%)	0.7
N/A	Ramp inside XWalk1?	N/A	N/A	Ramp inside XWalk2?	N/A
	Road Slope (%)	3.4		Clear Space?	N/A
	Road X Slope (%)	6.2	N/A	Clear Space to XWalk (in)	N/A
			N/A	Any Obstruction?	N/A
				Obstruction Type	N/A
			N/A	Storm Grate/Utility Hazard?	N/A
				Storm Grate/Utility Type	N/A
Yes	Surface Condition? (G/P)	Good			
	Curb Slope (%)	23.6

**Remove & Replace Curb Ramp With Two New Directional Ramps or Equivalent.**
