# Access Compliance Report

## Public Rights-of-Way

| Intersection ID: 12849 | Main Street: E MARTIN LUTHER KING JR BV | Cross Street: S BREVARD ST | Location: E |
| ADA ID: 01E4F06D4D13 | Ramp Type: BlendTrans1 | Initial Pass/Fail: Pass | Overall Compliance: No |

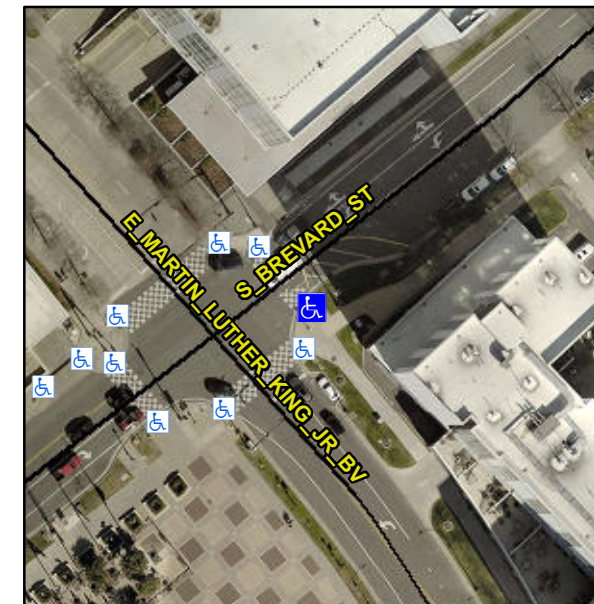
| Severity Score: 5.25 | | | |

**R304.5.3, R305.2, R304.5.4**

| Compliance | Description | Data | Compliance | Description | Data |
|---|---|---|---|---|---|
| Yes | Ramp Width (in) | 48.0 | No | BlendTrans XSlope (%) | 2.8 |
| N/A | Landing Curb? (Y/N) | No | No | DWS Offset (in) | 5.5 |
| Yes | Gutter Ponding? | No | No | Gutter Slope (%) | 5.5 |
| Yes | Gutter Lip Ht (in) | 0.0 | No | Gutter X Slope (%) | 3.1 |

**Remove & Replace Curb Ramp With Two New Directional Ramps or Equivalent. Remove & Replace Gutter.**
