## Access Compliance Report Public Rights-of-Way (Curb Ramps)

Intersection ID: 3137 Main Street: ALAMEDA\_LN Cross Street: STONE\_PARK\_DR Location: SE

ADA ID: 01E629ED1EFF Ramp Type: Perp Initial Pass/Fail: Fail Overall Compliance: No Severity Score: 13.75

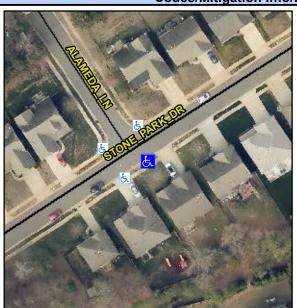
Possible Solutions:	0
Remove & Replace Entire Ramp.	N
	Υ
	N
	N
	N
	N
Surveyor Notes:	N
N/A	N
	N
	N
	N
PROW/ADA:	N
Not Found, R304.2.2, R304.5.3	N
	N
	N

Field Measurements/Component Compliance						
Compl	iance Description	Data	Comp	liance l	Description	Data
N/A	Ramp Length (in)	46.5	No	Ramp	Slope (%)	8.6
Yes	Ramp Width (in)	48.0	No	Ramp 2	XSlope (%)	2.1
N/A	Flare Type LT	N/A	N/A	Flare T	ype RT	N/A
N/A	Flare Slope LT (%)	N/A	N/A	Flare S	Slope RT (%)	N/A
N/A	Flare Traversable LT?	N/A	N/A	Flare T	raversable RT?	N/A
N/A	Landing Length (in)	N/A	N/A	DWS F	Provided?	N/A
N/A	Landing Width (in)	N/A	N/A	DWS C	Contrast?	N/A
N/A	Landing Slope (%)	N/A	N/A	DWS L	ength (in)	N/A
N/A	Landing X Slope (%)	N/A	N/A	DWS F	ull Width?	N/A
N/A	Landing Curb? (Y/N)	N/A	N/A	DWS (	Offset (in)	N/A
N/A	Shared Landing?	N/A				
N/A	Gutter Ponding?	N/A	N/A	Gutter	Slope (%)	N/A
N/A	Gutter Lip Ht (in)	N/A	N/A	Gutter	X Slope (%)	N/A
N/A	Painted X Walk1?	No	N/A	Painted	d X Walk2?	N/A
	X Walk 1 Direction	To N		X Walk	2 Direction	N/A
N/A	X Walk 1 Width (in)	N/A	N/A	X Walk	2 Width (in)	N/A
	X Walk 1 Slope (%)	5.0		X Walk	2 Slope (%)	N/A
