Access Compliance Report

Public Rights-of-Way

(Curb Ramps)

Intersection ID: 12787	Main Street: BANDY_DR	Cross Street: PENCE_RD	Location: NW
ADA ID: 021BF5A8FBA1	Ramp Type: Combination2	Initial Pass/Fail: Fail	Overall Compliance: No
Codes/Mitigation Info/Possible Solution			Severity Score: 55
			Field Measurements/Component Compliance

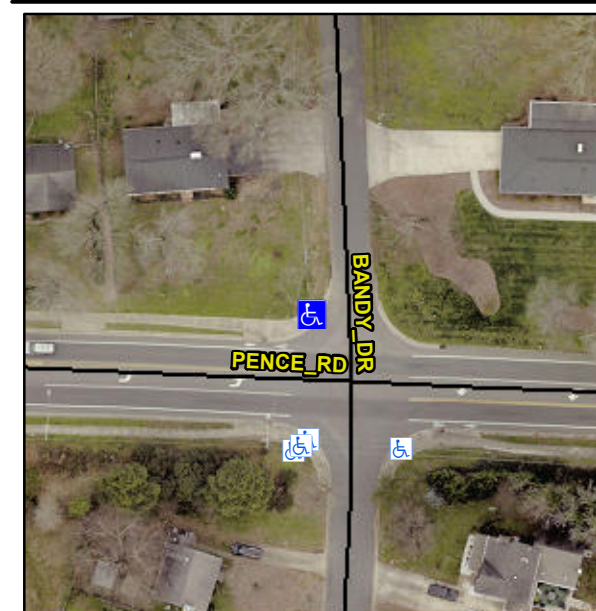
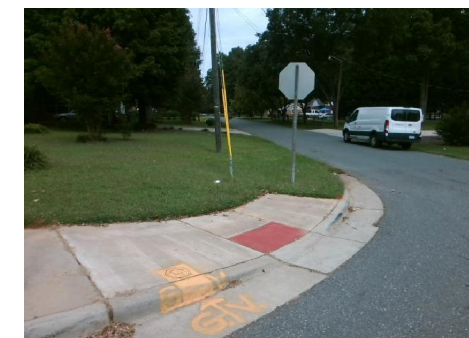
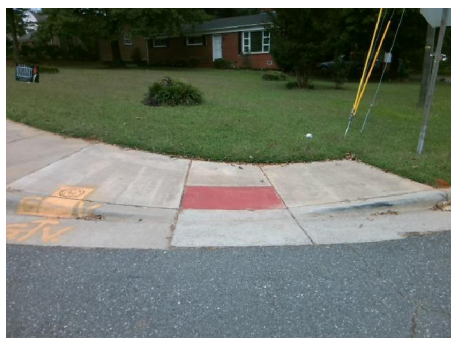
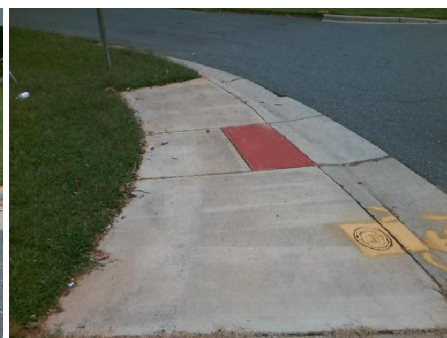
Not Found, R304.5.1, R304.5.3, R304.3.2

Compliance	Description	Data	Compliance	Description	Data
N/A	Ramp Length LT (in)	59.0	N/A	Ramp Length RT (in)	N/A
Yes	Ramp Width LT (in)	67.0	N/A	Ramp Width RT (in)	N/A
No	Ramp Slope LT (%)	13.9	N/A	Ramp Slope RT (%)	N/A
No	Ramp XSlope LT (%)	5.3	N/A	Ramp XSlope RT (%)	N/A
N/A	Ramp Length (in)	61.0	Yes	Ramp Slope (%)	8.0
No	Ramp Width (in)	32.0	No	Ramp XSlope (%)	5.2
N/A	Flare Type LT	N/A	N/A	Flare Type RT	N/A
N/A	Flare Slope LT (%)	N/A	N/A	Flare Slope RT (%)	N/A
N/A	Flare Traversable LT?	N/A	N/A	Flare Traversable RT?	N/A
N/A	Landing Length (in)	N/A	N/A	DWS Provided?	N/A
N/A	Landing Width (in)	N/A	N/A	DWS Contrast?	N/A
N/A	Landing Slope (%)	N/A	N/A	DWS Length (in)	N/A
N/A	Landing X Slope (%)	N/A	N/A	DWS Full Width?	N/A
N/A	Landing Curb? (Y/N)	N/A	N/A	DWS Offset (in)	N/A
N/A	Shared Landing?	N/A			
N/A	Gutter Ponding?	N/A	N/A	Gutter Slope (%)	N/A
N/A	Gutter Lip Ht (in)	N/A	N/A	Gutter X Slope (%)	N/A
N/A	Painted X Walk1?	No	N/A	Painted X Walk2?	N/A

Remove & Replace Entire Ramp.
