Access Compliance Report

Public Rights-of-Way

(Curb Ramps)

Intersection ID: 53963	Main Street: MAGNOLIA LILY AV	Cross Street: LILAC TREE AV	Location: SW
ADA ID: 030BCB2E238F	Ramp Type: Perp	Initial Pass/Fail: Fail	Overall Compliance: No
Severity Score: 10			
Codes/Mitigation Info/Possible Solution		Field Measurements/Component Compliance

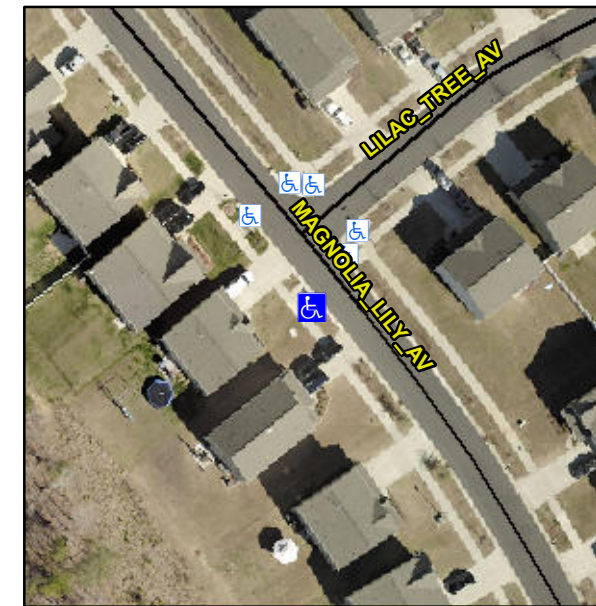
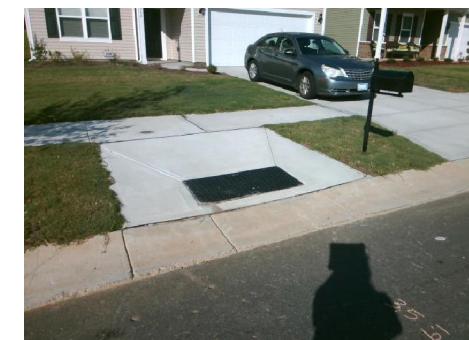
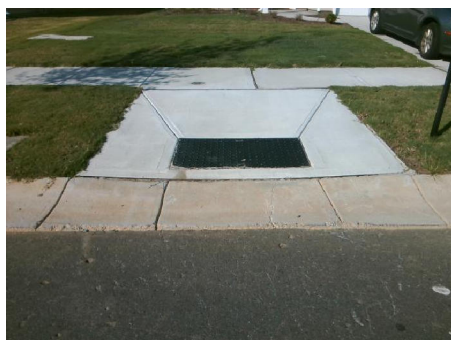
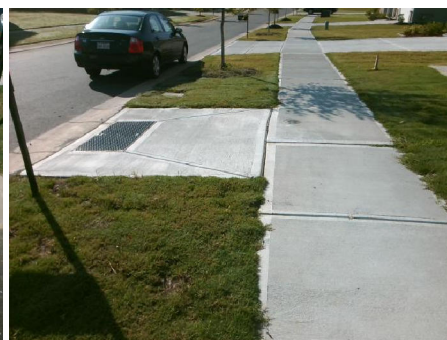
Not Found, R304.5.1, R304.5.3

Compliance	Description	Data	Compliance	Description	Data
N/A	Ramp Length (in)	94.0	Yes	Ramp Slope (%)	7.0
No	Ramp Width (in)	47.5	No	Ramp XSlope (%)	2.4
N/A	Flare Type LT	N/A	N/A	Flare Type RT	N/A
N/A	Flare Slope LT (%)	N/A	N/A	Flare Slope RT (%)	N/A
N/A	Flare Traversable LT?	N/A	N/A	Flare Traversable RT?	N/A
N/A	Landing Length (in)	N/A	N/A	DWS Provided?	N/A
N/A	Landing Width (in)	N/A	N/A	DWS Contrast?	N/A
N/A	Landing Slope (%)	N/A	N/A	DWS Length (in)	N/A
N/A	Landing X Slope (%)	N/A	N/A	DWS Full Width?	N/A
N/A	Landing Curb? (Y/N)	N/A	N/A	DWS Offset (in)	N/A
N/A	Shared Landing?	N/A			
N/A	Gutter Ponding?	N/A	N/A	Gutter Slope (%)	N/A
N/A	Gutter Lip Ht (in)	1.0	N/A	Gutter X Slope (%)	N/A
N/A	Painted X Walk1?	No	N/A	Painted X Walk2?	N/A
	X Walk 1 Direction	To E		X Walk 2 Direction	N/A
N/A	X Walk 1 Width (in)	N/A	N/A	X Walk 2 Width (in)	N/A
	X Walk 1 Slope (%)	3.5		X Walk 2 Slope (%)	N/A
	X Walk 1 X Slope (%)	1.9		X Walk 2 X Slope (%)	N/A

N/A	Ramp inside XWalk1?	N/A	N/A	Ramp inside XWalk2?	N/A
	Road Slope (%)	N/A	N/A	Clear Space?	N/A
	Road X Slope (%)	N/A	N/A	Clear Space to XWalk (in)	N/A
N/A	Any Obstructions?	N/A	N/A	Storm Grate/Utility Hazard?	N/A
	Obstruction Type			Storm Grate/Utility Type	
		N/A			N/A
			Yes	Surface Condition? (G/P)	Good

Remove & Replace Entire Ramp.
