Access Compliance Report Public Rights-of-Way (Curb Ramps)

Intersection ID: 44057 Main Street: HOLLAND_PARK_LN Cross Street: LONGSTONE_LN Location: N

ADA ID: 03A6A74CB95C Ramp Type: PerpDiag Initial Pass/Fail: Fail Overall Compliance: No Severity Score: 60

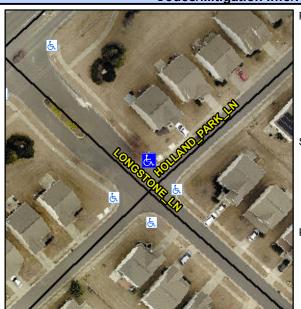
Not Found, R304.5.1, R304.5.3

Compliance Description Data		Comp	liance Description	Data	
N/A	Ramp Length (in)	71.5	Yes	Ramp Slope (%)	6.8
No	Ramp Width (in)	28.0	No	Ramp XSlope (%)	7.2
N/A	Flare Type LT	N/A	N/A	Flare Type RT	N/A
N/A	Flare Slope LT (%)	N/A	N/A	Flare Slope RT (%)	N/A
N/A	Flare Traversable LT?	N/A	N/A	Flare Traversable RT?	N/A
N/A	Landing Length (in)	N/A	N/A	DWS Provided?	N/A
N/A	Landing Width (in)	N/A	N/A	DWS Contrast?	N/A
N/A	Landing Slope (%)	N/A	N/A	DWS Length (in)	N/A
N/A	Landing X Slope (%)	N/A	N/A	DWS Full Width?	N/A
N/A	Landing Curb? (Y/N)	N/A	N/A	DWS Offset (in)	N/A
N/A	Shared Landing?	N/A			
N/A	Gutter Ponding?	N/A	N/A	Gutter Slope (%)	N/A
N/A	Gutter Lip Ht (in)	N/A	N/A	Gutter X Slope (%)	N/A
N/A	Painted X Walk1?	No	N/A	Painted X Walk2?	No
	X Walk 1 Direction	To SW		X Walk 2 Direction	To SE
N/A	X Walk 1 Width (in)	N/A	N/A	X Walk 2 Width (in)	N/A
	X Walk 1 Slope (%)	1.2		X Walk 2 Slope (%)	6.5
	X Walk 1 X Slope (%)	6.5		X Walk 2 X Slope (%)	0.5

N/A	Ramp inside XWalk1?	N/A	N/A	Ramp inside XWalk2?	N/A
	Road Slope (%)	4.2	N/A	Clear Space?	N/A
	Road X Slope (%)	6.2	N/A	Clear Space to XWalk (in)	N/A
N/A	Any Obstructions?	N/A	N/A	Storm Grate/Utility Hazard?	N/A
	Obstruction Type			Storm Grate/Utility Type	
		N/A			N/A

Remove & Replace Curb Ramp With
Two New Directional Ramps or
Equivalent.
