Access Compliance Report Public Rights-of-Way (Curb Ramps)

Intersection ID: N/AMain Street:SPRINGWOOD_ESTATE_DRCross Street:BELVEDERE_CASTLE_DRLocation:SWADA ID: 0403B5DAE86CRamp Type:BlendTrans1Initial Pass/Fail:FailOverall Compliance:NoSeverity Score:21.25

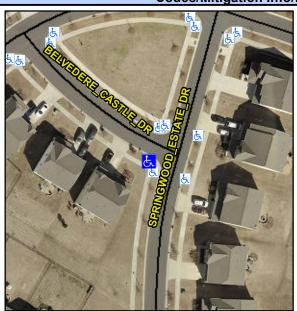
Not Found, R304.5.1, R304.5.3

Compliance Description Data Compliance Description Data					
N/A	Ramp Length (in)	97.0	Yes	BlendTrans Slope (%)	4.3
No	Ramp Width (in)	46.5	No	BlendTrans XSlope (%)	5.3
N/A	Flare Type LT	N/A	N/A	Flare Type RT	N/A
N/A	Flare Slope LT (%)	N/A	N/A	Flare Slope RT (%)	N/A
N/A	Flare Traversable LT?	N/A	N/A	Flare Traversable RT?	N/A
N/A	Landing Length (in)	N/A	N/A	DWS Provided?	N/A
N/A	Landing Width (in)	N/A	N/A	DWS Contrast?	N/A
N/A	Landing Slope (%)	N/A	N/A	DWS Length (in)	N/A
N/A	Landing X Slope (%)	N/A	N/A	DWS Full Width?	N/A
N/A	Landing Curb? (Y/N)	N/A	N/A	DWS Offset (in)	N/A
N/A	Shared Landing?	N/A			
N/A	Gutter Ponding?	N/A	N/A	Gutter Slope (%)	N/A
N/A	Gutter Lip Ht (in)	N/A	N/A	Gutter X Slope (%)	N/A
N/A	Painted X Walk1?	No	N/A	Painted X Walk2?	N/A
	X Walk 1 Direction	To N		X Walk 2 Direction	N/A
	X Walk 1 Width (in)	N/A		X Walk 2 Width (in)	N/A
	X Walk 1 Slope (%)	3.4		X Walk 2 Slope (%)	N/A
	X Walk 1 X Slope (%)	2.3		X Walk 2 X Slope (%)	N/A

N/A	Ramp inside XWalk1?	N/A	N/A	Ramp inside XWalk2?	N/A
	Road Slope (%)	2.3		Clear Space?	N/A
	Road X Slope (%)	3.4	N/A	Clear Space to XWalk (in)	N/A
N/A	Any Obstructions?	N/A	N/A	Storm Grate/Utility Hazard?	N/A
	Obstruction Type		l	Storm Grate/Utility Type	
		N/A	l		N/A
			Yes	Surface Condition? (G/P)	Good
				Curb Slope (%)	7.6

Remove & Replace Curb Ramp With Two New Directional Ramps or Equivalent.
