Access Compliance Report

Public Rights-of-Way

(Curb Ramps)

Intersection ID: 11511	Main Street: E_18TH_ST	Cross Street: N_DAVIDSON_ST	Location: E
ADA ID: 040A616DC4A8	Ramp Type: PerpDiag	Initial Pass/Fail: Fail	Overall Compliance: No
			Severity Score: 21.25

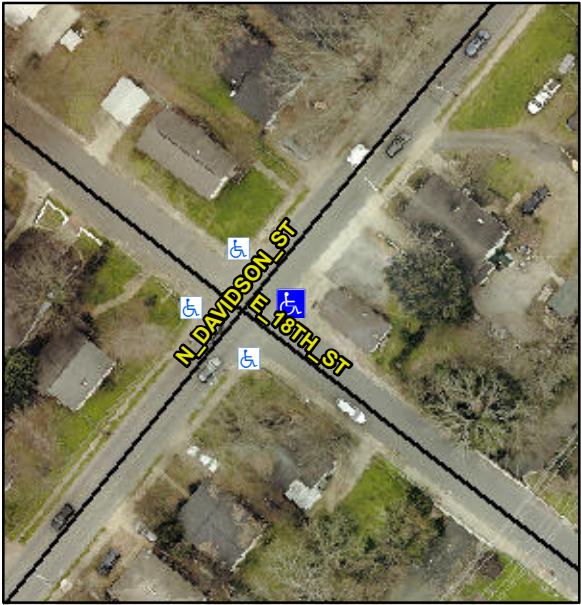
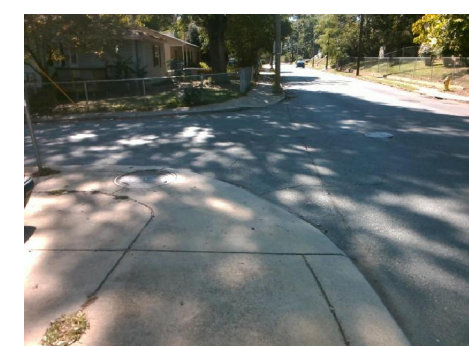
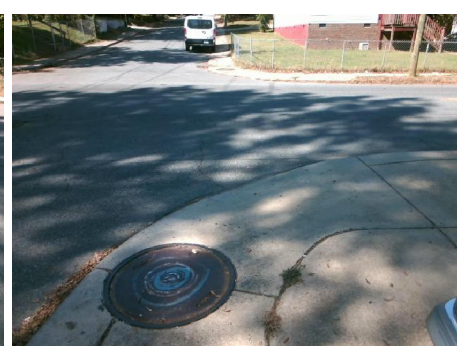
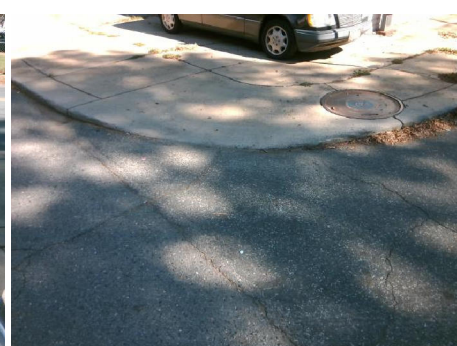
Possible Solutions:		Compliance	Description	Data
	Remove & Replace Curb Ramp With Two New Directional Ramps or Equivalent.		No	Ramp Length (in)	56.0
			No	Ramp Width (in)	40.0
			N/A	Flare Type LT	N/A
			N/A	Flare Slope LT (%)	N/A
			N/A	Flare Traversable LT?	N/A
			N/A	Landing Length (in)	N/A
			N/A	Landing Width (in)	N/A
			N/A	Landing Slope (%)	N/A
			N/A	Landing X Slope (%)	N/A
<p>Surveyor Notes:</p> <p>N/A</p> <p>PROW/ADA:</p> <p>Not Found, R304.5.1, R304.2.2</p>			N/A	Flare Type RT	N/A
			N/A	Flare Slope RT (%)	N/A
			N/A	Flare Traversable RT?	N/A
			N/A	DWS Provided?	N/A
			N/A	DWS Contrast?	N/A
			N/A	DWS Length (in)	N/A
			N/A	DWS Full Width?	N/A
			N/A	DWS Offset (in)	N/A
			N/A	Gutter Ponding?	N/A
			N/A	Gutter Lip Ht (in)	N/A
<p>Total Cost:</p> <p>\$ 3200.00</p>			No	Painted X Walk1?	No
				X Walk 1 Direction	To NW

N/A	X Walk 1 Width (in)	N/A
			4.8	X Walk 1 Slope (%)	1.8
			1.6	X Walk 1 X Slope (%)	2.6
			N/A	Ramp inside XWalk1?	N/A
			0.3	Road Slope (%)	N/A
			5.7	Road X Slope (%)	N/A
			N/A	Any Obstructions?	N/A
				Obstruction Type	
			N/A	Storm Grate/Utility Hazard?	N/A
			N/A	Storm Grate/Utility Type	N/A
			Yes	Surface Condition? (G/P)	Good
