# Access Compliance Report

## Public Rights-of-Way

### (Curb Ramps)

Intersection ID: 44958	Main Street: N_TRYON_ST	Cross Street: OLD_CONCORD_RD	Location: SE
ADA ID: 043336760AE6	Ramp Type: Combination1	Initial Pass/Fail: Fail	Overall Compliance: No
Severity Score: 22.5			
Codes/Mitigation Info/Possible Solution		Field Measurements/Component Compliance

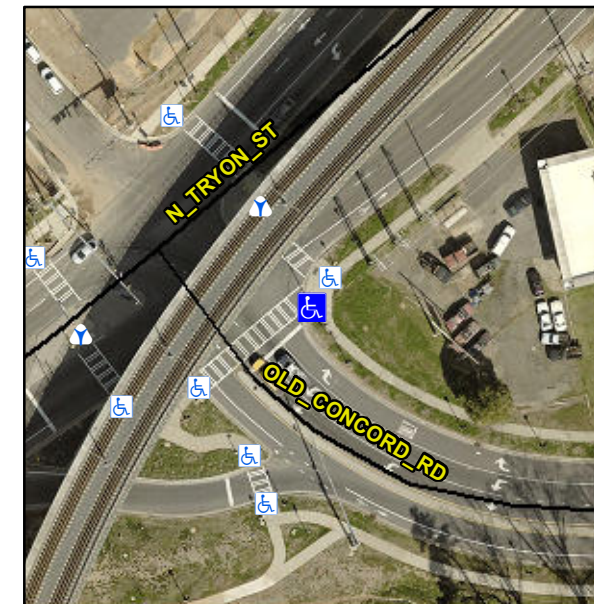
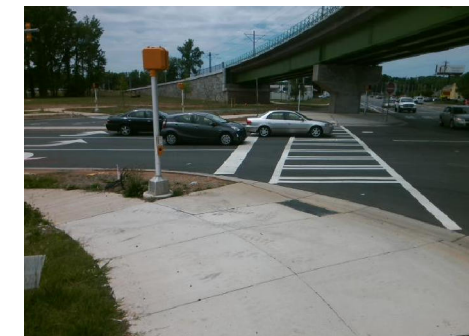
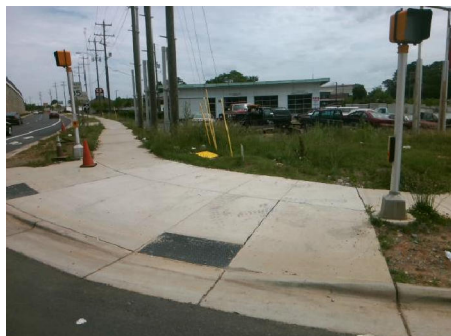
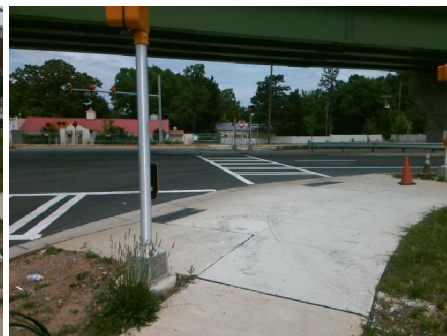
**R304.5.1, R304.2.2, R304.3.2**

Compliance	Description	Data	Compliance	Description	Data
N/A	Ramp Length LT (in)	62.0	N/A	Ramp Length RT (in)	48.0
Yes	Ramp Width LT (in)	71.0	Yes	Ramp Width RT (in)	72.0
Yes	Ramp Slope LT (%)	6.3	No	Ramp Slope RT (%)	9.1
Yes	Ramp XSlope LT (%)	0.3	Yes	Ramp XSlope RT (%)	1.0
N/A	Ramp Length (in)	99.0	No	Ramp Slope (%)	8.9
No	Ramp Width (in)	41.0	Yes	Ramp XSlope (%)	4.5
N/A	Flare Type LT	N/A	N/A	Flare Type RT	N/A
N/A	Flare Slope LT (%)	N/A	N/A	Flare Slope RT (%)	N/A
N/A	Flare Traversable LT?	N/A	N/A	Flare Traversable RT?	N/A
N/A	Landing Length (in)	N/A	N/A	DWS Provided?	N/A
N/A	Landing Width (in)	N/A	N/A	DWS Contrast?	N/A
N/A	Landing Slope (%)	N/A	N/A	DWS Length (in)	N/A
N/A	Landing X Slope (%)	N/A	N/A	DWS Full Width?	N/A
N/A	Landing Curb? (Y/N)	N/A	N/A	DWS Offset (in)	N/A
N/A	Shared Landing?	N/A			
N/A	Gutter Ponding?	N/A	N/A	Gutter Slope (%)	N/A
N/A	Gutter Lip Ht (in)	N/A	N/A	Gutter X Slope (%)	N/A
N/A	Painted X Walk1?	Yes	N/A	Painted X Walk2?	N/A

**Remove & Replace Entire Ramp.**
