# Access Compliance Report

## Public Rights-of-Way

### (Curb Ramps)

| Intersection ID: 11217 | Main Street: ASHLEY_RD | Cross Street: BULLARD_ST | Location: S |

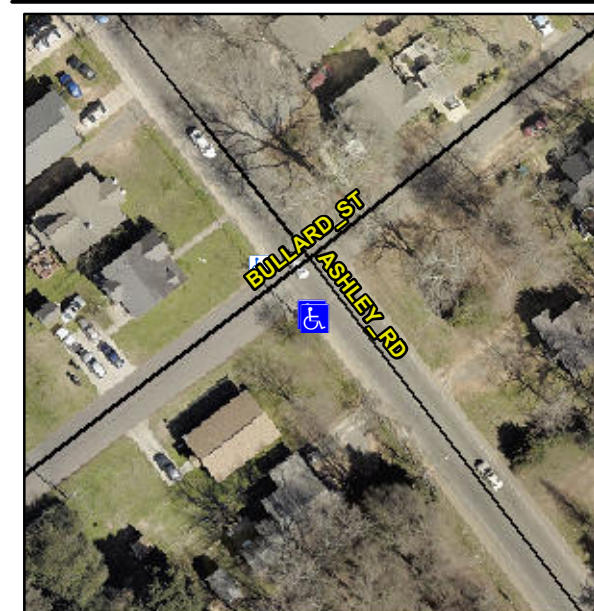
| ADA ID: 0484C547B409 | Ramp Type: Perp | Initial Pass/Fail: Fail | Overall Compliance: No |

**R304.2.2, R304.5.3**

| Compliance | Description | Data | Compliance | Description | Data |
|---|---|---|---|---|---|
| N/A | Ramp Length (in) | 54.0 | No | Ramp Slope (%) | 12.2 |
| Yes | Ramp Width (in) | 48.0 | No | Ramp XSlope (%) | 5.9 |

**Remove & Replace Entire Ramp.**
