Access Compliance Report

Public Rights-of-Way

(Curb Ramps)

Intersection ID: 42552	Main Street: ESTHER_LN	Cross Street: LUNDY_LN	Location: N
ADA ID: 051C05AC71FD	Ramp Type: Perp	Initial Pass/Fail: Fail	Overall Compliance: No
Severity Score: 13.75			
Codes/Mitigation Info/Possible Solution		Field Measurements/Component Compliance

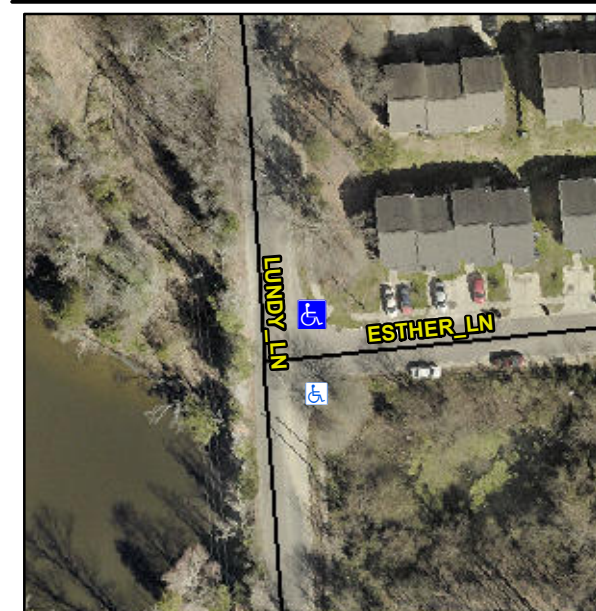
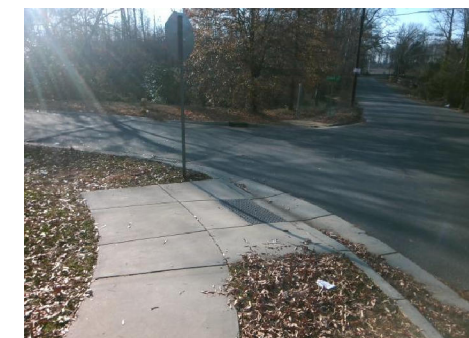
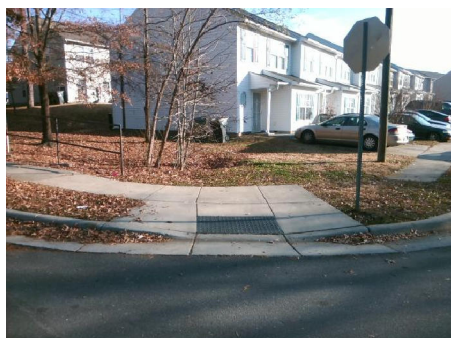
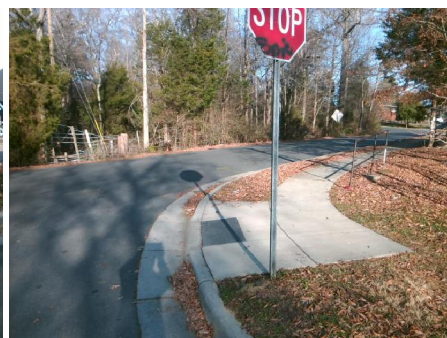
Not Found, R304.2.2, R304.5.3

Compliance	Description	Data	Compliance	Description	Data
N/A	Ramp Length (in)	49.0	No	Ramp Slope (%)	9.9
Yes	Ramp Width (in)	48.0	No	Ramp XSlope (%)	3.7
N/A	Flare Type LT	N/A	N/A	Flare Type RT	N/A
N/A	Flare Slope LT (%)	N/A	N/A	Flare Slope RT (%)	N/A
N/A	Flare Traversable LT?	N/A	N/A	Flare Traversable RT?	N/A
N/A	Landing Length (in)	N/A	N/A	DWS Provided?	N/A
N/A	Landing Width (in)	N/A	N/A	DWS Contrast?	N/A
N/A	Landing Slope (%)	N/A	N/A	DWS Length (in)	N/A
N/A	Landing X Slope (%)	N/A	N/A	DWS Full Width?	N/A
N/A	Landing Curb? (Y/N)	N/A	N/A	DWS Offset (in)	N/A
N/A	Shared Landing?	N/A			
N/A	Gutter Ponding?	N/A	N/A	Gutter Slope (%)	N/A
N/A	Gutter Lip Ht (in)	N/A	N/A	Gutter X Slope (%)	N/A
N/A	Painted X Walk1?	No	N/A	Painted X Walk2?	N/A
	X Walk 1 Direction	To S		X Walk 2 Direction	N/A
N/A	X Walk 1 Width (in)	N/A	N/A	X Walk 2 Width (in)	N/A
	X Walk 1 Slope (%)	3.1		X Walk 2 Slope (%)	N/A
	X Walk 1 X Slope (%)	0.8		X Walk 2 X Slope (%)	N/A

Remove & Replace Entire Ramp.
