Access Compliance Report Public Rights-of-Way (Curb Ramps)

Intersection ID: 42982 Main Street: LADORA_DR Cross Street: LAVENDER_CR Location: SE

ADA ID: 0542EC43E533 Ramp Type: PerpDiag Initial Pass/Fail: Fail Overall Compliance: No Severity Score: 22.5

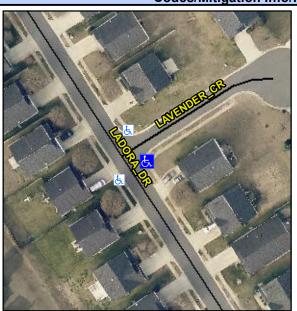
Not Found, R304.5.1, R304.2.2, R304.5.3

Compliance Description Data Compliance Description Data No N/A Ramp Length (in) 48.5 Ramp Slope (%) 9.5 No Ramp XSlope (%) No Ramp Width (in) 37.0 2.6 N/A N/A Flare Type LT N/A Flare Type RT N/A N/A N/A N/A Flare Slope RT (%) N/A Flare Slope LT (%) N/A Flare Traversable LT? N/A N/A Flare Traversable RT? N/A N/A N/A N/A DWS Provided? N/A Landing Length (in) N/A Landing Width (in) N/A N/A **DWS Contrast?** N/A N/A N/A N/A Landing Slope (%) DWS Length (in) N/A N/A Landing X Slope (%) N/A N/A DWS Full Width? N/A N/A Landing Curb? (Y/N) N/A N/A DWS Offset (in) N/A N/A N/A Shared Landing? N/A Gutter Ponding? N/A N/A Gutter Slope (%) N/A N/A Gutter Lip Ht (in) N/A N/A Gutter X Slope (%) N/A N/A Painted X Walk1? No N/A Painted X Walk2? No X Walk 1 Direction To N X Walk 2 Direction To W N/A N/A X Walk 1 Width (in) X Walk 2 Width (in) N/A X Walk 1 Slope (%) 1.7 X Walk 2 Slope (%) 3.9 X Walk 1 X Slope (%) 3.8 X Walk 2 X Slope (%) 3.1 N/A N/A N/A Ramp inside XWalk2? N/A Ramp inside XWalk1? Road Slope (%) 4.7 N/A Clear Space? N/A N/A Road X Slope (%) 2.8 Clear Space to XWalk (in) N/A N/A N/A N/A Any Obstructions? Storm Grate/Utility Hazard? N/A **Obstruction Type** Storm Grate/Utility Type N/A N/A Yes Surface Condition? (G/P) Good

LAVENDER CIR StopSign LADORA DR None Possible Solutions:

Remove & Replace Curb Ramp With Two New Directional Ramps or Equivalent.
