Access Compliance Report Public Rights-of-Way (Curb Ramps)

Intersection ID: 28041 Main Street: CORRYSTONE_DR Cross Street: VICTORIA_MILL_CT Location: S

ADA ID: 05A59F78E07C Ramp Type: PerpDiag Initial Pass/Fail: Fail Overall Compliance: No Severity Score: 60

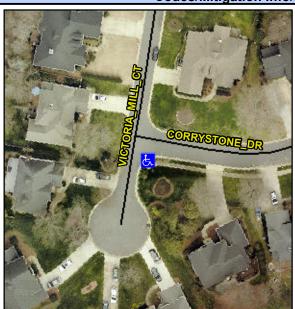
Not Found, R304.5.1, R304.2.2, R304.5.3

Field Measurements/Component Compnance					
Compliance Description		Data	Compliance Description		Data
N/A	Ramp Length (in)	94.0	No	Ramp Slope (%)	11.1
No	Ramp Width (in)	28.0	No	Ramp XSlope (%)	6.4
N/A	Flare Type LT	N/A	N/A	Flare Type RT	N/A
N/A	Flare Slope LT (%)	N/A	N/A	Flare Slope RT (%)	N/A
N/A	Flare Traversable LT?	N/A	N/A	Flare Traversable RT?	N/A
N/A	Landing Length (in)	N/A	N/A	DWS Provided?	N/A
N/A	Landing Width (in)	N/A	N/A	DWS Contrast?	N/A
N/A	Landing Slope (%)	N/A	N/A	DWS Length (in)	N/A
N/A	Landing X Slope (%)	N/A	N/A	DWS Full Width?	N/A
N/A	Landing Curb? (Y/N)	N/A	N/A	DWS Offset (in)	N/A
N/A	Shared Landing?	N/A			
N/A	Gutter Ponding?	N/A	N/A	Gutter Slope (%)	N/A
N/A	Gutter Lip Ht (in)	N/A	N/A	Gutter X Slope (%)	N/A
N/A	Painted X Walk1?	No	N/A	Painted X Walk2?	No
	X Walk 1 Direction	To NE		X Walk 2 Direction	To W
N/A	X Walk 1 Width (in)	N/A	N/A	X Walk 2 Width (in)	N/A
	X Walk 1 Slope (%)	0.0		X Walk 2 Slope (%)	2.2

Remove & Replace Curb Ramp With Two New Directional Ramps or Equivalent.
