# Access Compliance Report

## Public Rights-of-Way

### (Curb Ramps)

Intersection ID: 12498	Main Street: BELMONT_AV	Cross Street: LOUISE_AV	Location:	N
ADA ID: 05E0275BA5C5	Ramp Type: Perp	Initial Pass/Fail: Fail	Overall Compliance: No	Severity Score: 12.5

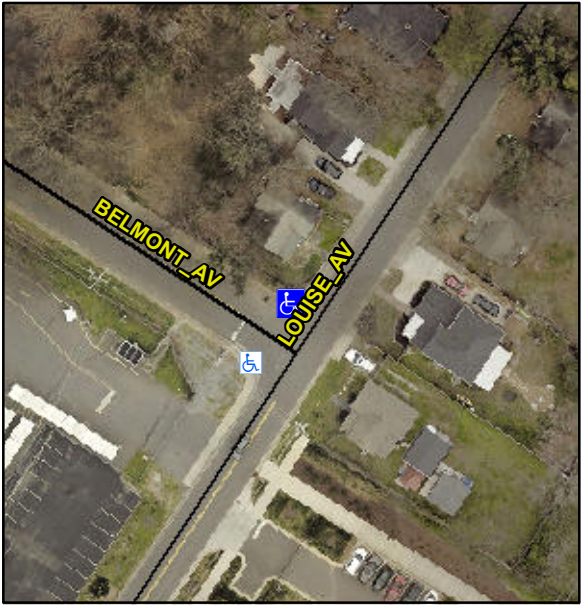
Possible Solutions:		<b>Compliance</b>	<b>Description</b>	<b>Data</b>
	<b>Remove &amp; Replace Entire Ramp.</b>		N/A	Ramp Length (in)	63.5
			Yes	Ramp Width (in)	48.0
			N/A	Flare Type LT	N/A
			N/A	Flare Slope LT (%)	N/A
			N/A	Flare Traversable LT?	N/A
			N/A	Landing Length (in)	N/A
			N/A	Landing Width (in)	N/A
			N/A	Landing Slope (%)	N/A
			N/A	Landing X Slope (%)	N/A
<p>Surveyor Notes:</p> <p><b>N/A</b></p> <p>PROW/ADA:</p> <p><b>R304.2.2</b></p>			N/A	Flare Type RT	N/A
			N/A	Flare Slope RT (%)	N/A
			N/A	Flare Traversable RT?	N/A
			N/A	DWS Provided?	N/A
			N/A	DWS Contrast?	N/A
			N/A	DWS Length (in)	N/A
			N/A	DWS Full Width?	N/A
			N/A	DWS Offset (in)	N/A
			N/A	Shared Landing?	N/A
			N/A	Gutter Ponding?	N/A
			N/A	Gutter Lip Ht (in)	N/A
			N/A	Painted X Walk1?	No
				X Walk 1 Direction	To SW
			N/A	X Walk 1 Width (in)	N/A

X Walk 1 Slope (%)	0.8
				X Walk 1 X Slope (%)	2.6
			N/A	Ramp inside XWalk1?	N/A
				Road Slope (%)	N/A
				Road X Slope (%)	N/A
			N/A	Any Obstructions?	N/A
Total Cost:		\$ 1850.00		Obstruction Type	
			N/A		N/A
			Yes	Surface Condition? (G/P)	Good
