# Access Compliance Report

## Public Rights-of-Way

### (Curb Ramps)

Intersection ID: N/A	Main Street: EASTWYCKE_PLACE_DR	Cross Street: HICKORY_GROVE_RD	Location: NW
ADA ID: 05E2AE37C242	Ramp Type: Combination2Diag	Initial Pass/Fail: Fail	Overall Compliance: No
		Severity Score: 0

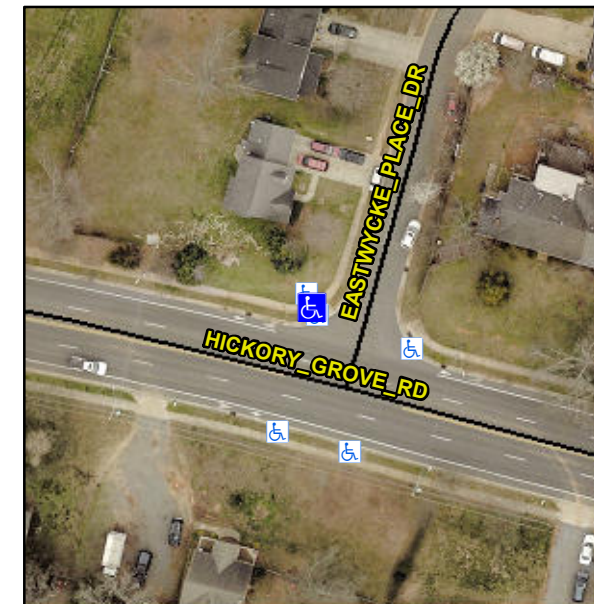
**Not Found, R304.5.1, R304.5.3, R304.3.2**

Compliance	Description	Data	Compliance	Description	Data
N/A	Ramp Length LT (in)	54.0	N/A	Ramp Length RT (in)	50.5
Yes	Ramp Width LT (in)	60.0	Yes	Ramp Width RT (in)	60.0
No	Ramp Slope LT (%)	8.7	Yes	Ramp Slope RT (%)	0.1
Yes	Ramp XSlope LT (%)	0.8	Yes	Ramp XSlope RT (%)	0.4
N/A	Ramp Length (in)	48.0	Yes	Ramp Slope (%)	7.1
No	Ramp Width (in)	40.5	No	Ramp XSlope (%)	2.9
N/A	Flare Type LT	N/A	N/A	Flare Type RT	N/A
N/A	Flare Slope LT (%)	N/A	N/A	Flare Slope RT (%)	N/A
N/A	Flare Traversable LT?	N/A	N/A	Flare Traversable RT?	N/A
N/A	Landing Length (in)	N/A	N/A	DWS Provided?	N/A
N/A	Landing Width (in)	N/A	N/A	DWS Contrast?	N/A
N/A	Landing Slope (%)	N/A	N/A	DWS Length (in)	N/A
N/A	Landing X Slope (%)	N/A	N/A	DWS Full Width?	N/A
N/A	Landing Curb? (Y/N)	N/A	N/A	DWS Offset (in)	N/A
N/A	Shared Landing?	N/A			
N/A	Gutter Ponding?	N/A	N/A	Gutter Slope (%)	N/A
N/A	Gutter Lip Ht (in)	N/A	N/A	Gutter X Slope (%)	N/A
N/A	Painted X Walk1?	No	N/A	Painted X Walk2?	No

**Remove & Replace Curb Ramp With Two New Directional Ramps or Equivalent.**
