Access Compliance Report

Public Rights-of-Way

(Curb Ramps)

Intersection ID: 27772	Main Street: BRIARWICK_LN	Cross Street: NORTH_COMMUNITY_HOUSE_RD	Location: NW
ADA ID: 05E2E316F307	Ramp Type: Combination1	Initial Pass/Fail: Fail	Overall Compliance: No
Severity Score: 12.5			
Codes/Mitigation Info/Possible Solution		Field Measurements/Component Compliance

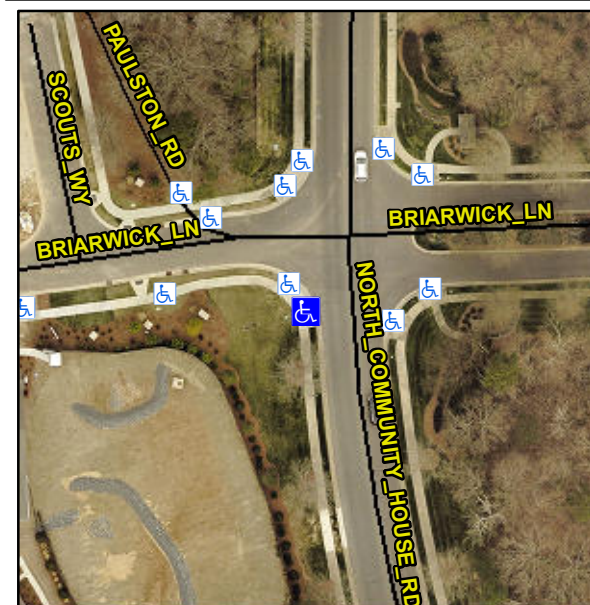
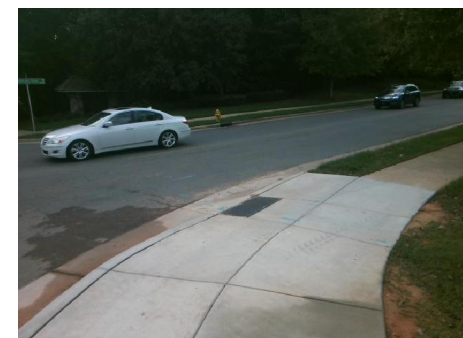
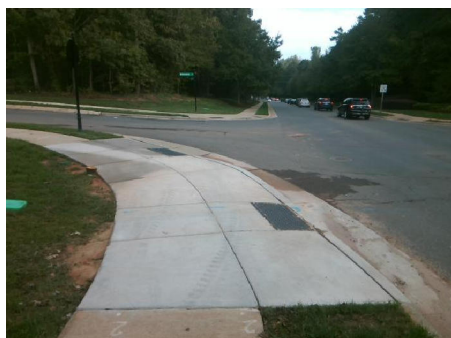
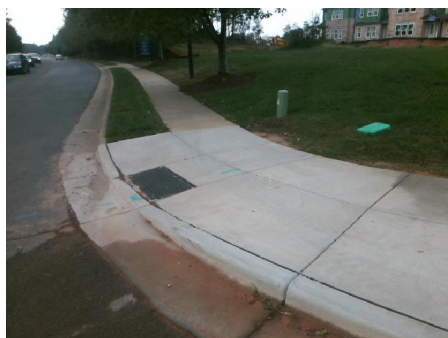
R304.2.2

Compliance	Description	Data	Compliance	Description	Data
N/A	Ramp Length LT (in)	58.0	N/A	Ramp Length RT (in)	56.0
Yes	Ramp Width LT (in)	58.0	Yes	Ramp Width RT (in)	54.0
Yes	Ramp Slope LT (%)	5.5	Yes	Ramp Slope RT (%)	5.1
Yes	Ramp XSlope LT (%)	1.7	Yes	Ramp XSlope RT (%)	0.5
N/A	Ramp Length (in)	54.0	No	Ramp Slope (%)	11.5
Yes	Ramp Width (in)	57.0	Yes	Ramp XSlope (%)	0.6
N/A	Flare Type LT	N/A	N/A	Flare Type RT	N/A
N/A	Flare Slope LT (%)	N/A	N/A	Flare Slope RT (%)	N/A
N/A	Flare Traversable LT?	N/A	N/A	Flare Traversable RT?	N/A
N/A	Landing Length (in)	N/A	N/A	DWS Provided?	N/A
N/A	Landing Width (in)	N/A	N/A	DWS Contrast?	N/A
N/A	Landing Slope (%)	N/A	N/A	DWS Length (in)	N/A
N/A	Landing X Slope (%)	N/A	N/A	DWS Full Width?	N/A
N/A	Landing Curb? (Y/N)	N/A	N/A	DWS Offset (in)	N/A
N/A	Shared Landing?	N/A			
N/A	Gutter Ponding?	N/A	N/A	Gutter Slope (%)	N/A
N/A	Gutter Lip Ht (in)	N/A	N/A	Gutter X Slope (%)	N/A
N/A	Painted X Walk1?	No	N/A	Painted X Walk2?	N/A

X Walk 1 Direction	To E		X Walk 2 Direction	N/A
	X Walk 1 Width (in)	N/A		X Walk 2 Width (in)	N/A
	X Walk 1 Slope (%)	2.4		X Walk 2 Slope (%)	N/A
	X Walk 1 X Slope (%)	3.0		X Walk 2 X Slope (%)	N/A
N/A	Ramp inside XWalk1?	N/A	N/A	Ramp inside XWalk2?	N/A
	Road Slope (%)	N/A		Clear Space?	N/A
	Road X Slope (%)	N/A	N/A	Clear Space to XWalk (in)	N/A
			N/A	Any Obstruction?	N/A
				Obstruction Type	N/A
			N/A	Storm Grate/Utility Hazard?	N/A
				Storm Grate/Utility Type	N/A
			Yes	Surface Condition? (G/P)	Good
				Curb Slope (%)	3.3

Remove & Replace Entire Ramp.
