Access Compliance Report

Public Rights-of-Way

(Curb Ramps)

Intersection ID: 9461	Main Street: BANCROFT_ST	Cross Street: W_28TH_ST	Location: E
ADA ID: 05F88883B1EB	Ramp Type: Combination2	Initial Pass/Fail: Fail	Overall Compliance: No
Severity Score: 13.75			
Codes/Mitigation Info/Possible Solution		Field Measurements/Component Compliance

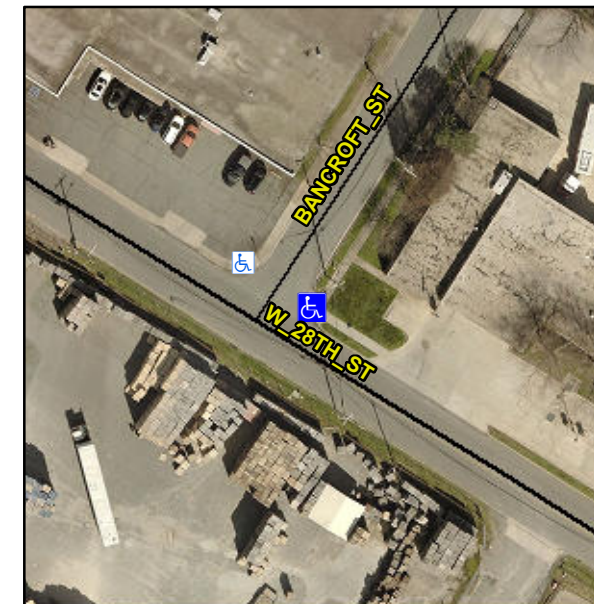
RT RP < 5%

Not Found, R304.2.2, R304.5.3

Possible Solutions:

Remove & Replace Entire Ramp.
