Access Compliance Report

Public Rights-of-Way

(Curb Ramps)

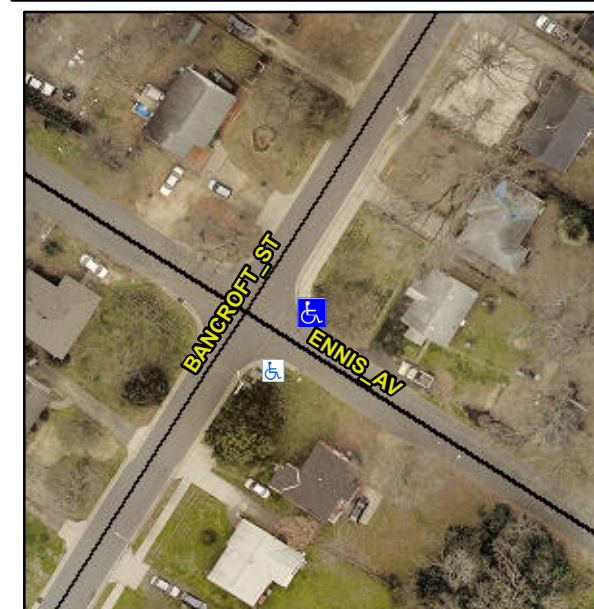
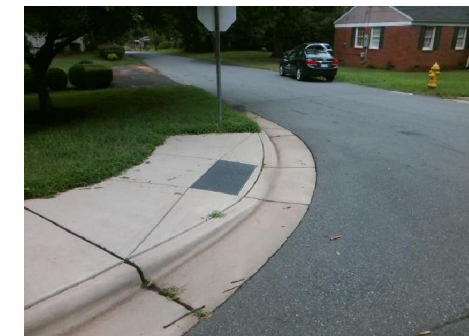
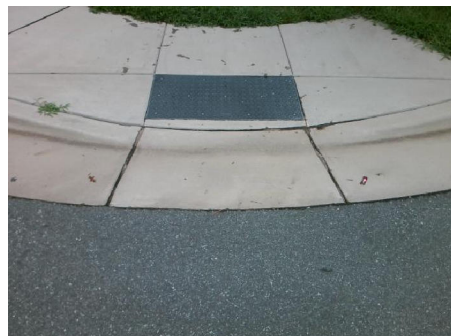
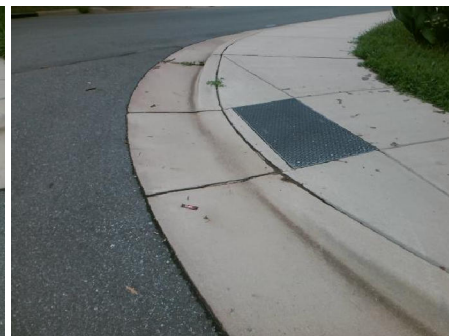
Intersection ID: 8931	Main Street: BANCROFT_ST	Cross Street: ENNIS_AV	Location: E
ADA ID: 05FC44596DF9	Ramp Type: Combination2	Initial Pass/Fail: Fail	Overall Compliance: No
Severity Score: 22.5			
Codes/Mitigation Info/Possible Solution		Field Measurements/Component Compliance

RT RP < 5%

**Not Found, R304.5.1, R304.5.1,
R304.5.3, R304.3.2**

Compliance	Description	Data	Compliance	Description	Data
N/A	Ramp Length LT (in)	42.5	N/A	Ramp Length RT (in)	43.5
No	Ramp Width LT (in)	45.5	N/A	Ramp Width RT (in)	45.5
No	Ramp Slope LT (%)	10.8	N/A	Ramp Slope RT (%)	1.7
Yes	Ramp XSlope LT (%)	1.3	N/A	Ramp XSlope RT (%)	1.8
N/A	Ramp Length (in)	27.5	Yes	Ramp Slope (%)	8.2
No	Ramp Width (in)	47.5	No	Ramp XSlope (%)	3.6
N/A	Flare Type LT	N/A	N/A	Flare Type RT	N/A
N/A	Flare Slope LT (%)	N/A	N/A	Flare Slope RT (%)	N/A
N/A	Flare Traversable LT?	N/A	N/A	Flare Traversable RT?	N/A
N/A	Landing Length (in)	N/A	N/A	DWS Provided?	N/A
N/A	Landing Width (in)	N/A	N/A	DWS Contrast?	N/A
N/A	Landing Slope (%)	N/A	N/A	DWS Length (in)	N/A
N/A	Landing X Slope (%)	N/A	N/A	DWS Full Width?	N/A
N/A	Landing Curb? (Y/N)	N/A	N/A	DWS Offset (in)	N/A
N/A	Shared Landing?	N/A			
N/A	Gutter Ponding?	N/A	N/A	Gutter Slope (%)	N/A
N/A	Gutter Lip Ht (in)	N/A	N/A	Gutter X Slope (%)	N/A
N/A	Painted X Walk1?	No	N/A	Painted X Walk2?	N/A

Remove & Replace Entire Ramp.
