Access Compliance Report Public Rights-of-Way (Curb Ramps)

Intersection ID: 10026308 Main Street: FAIRVIEW_RD Cross Street: N/A Location: SW **Severity Score:** Initial Pass/Fail: Fail **Overall Compliance: No** ADA ID: 063A0D6F10C7 Ramp Type: Perp 22.5

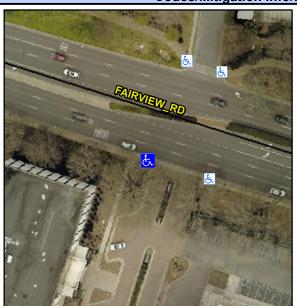
| Possible Solution | |
|---|---|
| R304.5.1, R304.2.2 | N/A |

| Field Measurements/Component Compliance | | | | | | | |
|---|---|---|---|---|---|---|--|
| N/A | Ramp Length (in) | 48.0 | No | Ram | Slope (%) | 10.8 | |
| No | Ramp Width (in) | 39.0 | Yes | Ram | XSlope (%) | 3.0 | |

| Possible Solution | |
|---|---|
| Remove & Replace Entire Ramp. | N/A |
