Access Compliance Report

Public Rights-of-Way

(Curb Ramps)

| Intersection ID: 9522 | Main Street: MARLENE_ST | Cross Street: SANTEE_ST | Location: NW |

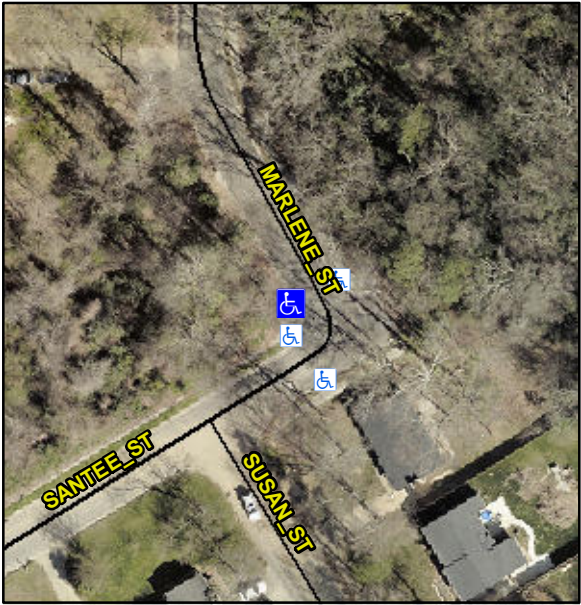
| ADA ID: 06CED810C884 | Ramp Type: Perp | Initial Pass/Fail: Fail | Overall Compliance: No |

| Codes/Mitigation Info/Possible Solution | | | Field Measurements/Component Compliance | | |
|---|--|---|---|---|---|
| | Remove & Replace Entire Ramp. | | No | Ramp Length (in) | 48.0 |
| | | | No | Ramp Width (in) | 47.0 |
| <p>Surveyor Notes:</p> <p>N/A</p> <p>PROW/ADA:</p> <p>Not Found, R304.5.1, R304.2.2</p> | | | N/A | Flare Type RT | N/A |
