Access Compliance Report

Public Rights-of-Way

(Curb Ramps)

Intersection ID: 28104	Main Street: CRUDEN_BAY_WY	Cross Street: DELMAHOY_DR	Location: SW
ADA ID: 07557AEC0412	Ramp Type: Perp	Initial Pass/Fail: Fail	Overall Compliance: No
Severity Score: 12.5			
Codes/Mitigation Info/Possible Solution		Field Measurements/Component Compliance

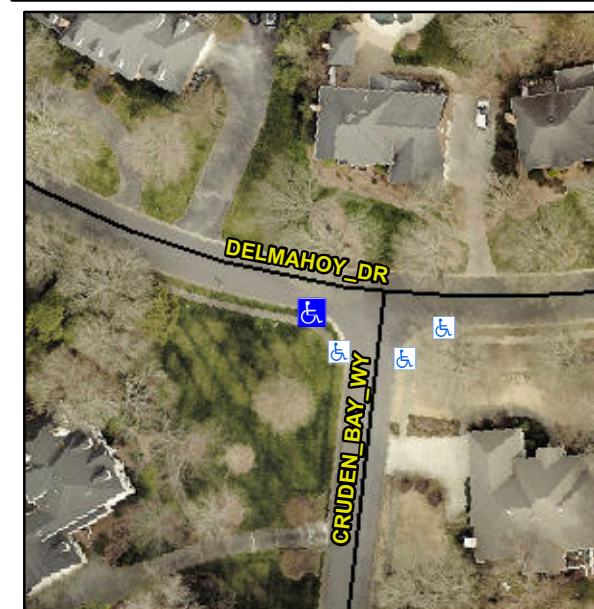
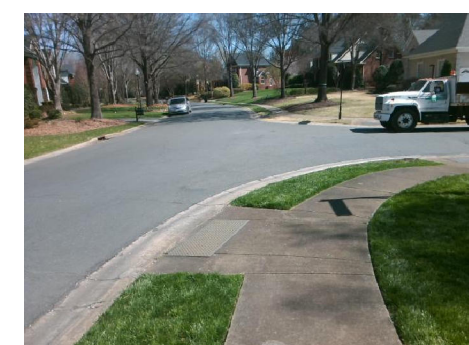
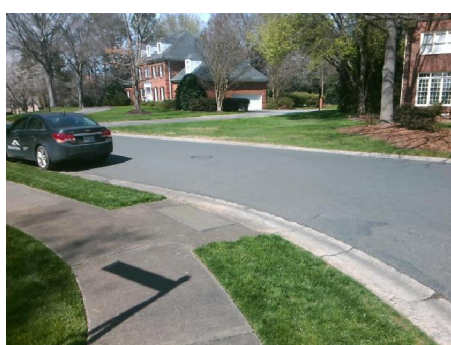
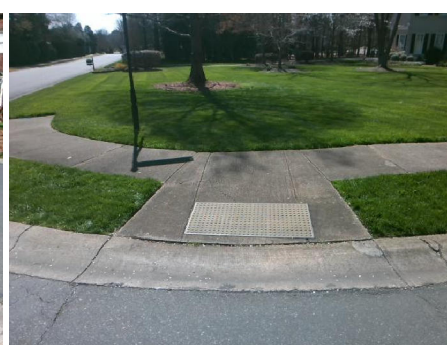
Not Found, R304.2.2

Compliance	Description	Data	Compliance	Description	Data
N/A	Ramp Length (in)	60.0	No	Ramp Slope (%)	9.6
Yes	Ramp Width (in)	48.0	Yes	Ramp XSlope (%)	1.5
N/A	Flare Type LT	N/A	N/A	Flare Type RT	N/A
N/A	Flare Slope LT (%)	N/A	N/A	Flare Slope RT (%)	N/A
N/A	Flare Traversable LT?	N/A	N/A	Flare Traversable RT?	N/A
N/A	Landing Length (in)	N/A	N/A	DWS Provided?	N/A
N/A	Landing Width (in)	N/A	N/A	DWS Contrast?	N/A
N/A	Landing Slope (%)	N/A	N/A	DWS Length (in)	N/A
N/A	Landing X Slope (%)	N/A	N/A	DWS Full Width?	N/A
N/A	Landing Curb? (Y/N)	N/A	N/A	DWS Offset (in)	N/A
N/A	Shared Landing?	N/A			
N/A	Gutter Ponding?	N/A	N/A	Gutter Slope (%)	N/A
N/A	Gutter Lip Ht (in)	N/A	N/A	Gutter X Slope (%)	N/A
N/A	Painted X Walk1?	No	N/A	Painted X Walk2?	N/A
	X Walk 1 Direction	To N		X Walk 2 Direction	N/A
N/A	X Walk 1 Width (in)	N/A	N/A	X Walk 2 Width (in)	N/A
	X Walk 1 Slope (%)	0.1		X Walk 2 Slope (%)	N/A
	X Walk 1 X Slope (%)	2.9		X Walk 2 X Slope (%)	N/A

Remove & Replace Entire Ramp.
