Access Compliance Report

Public Rights-of-Way

(Curb Ramps)

Intersection ID: 10570	Main Street: HERRIN_AV	Cross Street: HOLT_ST	Location: NW
ADA ID: 075B3326148B	Ramp Type: Combination1	Initial Pass/Fail: Fail	Overall Compliance: No
			Severity Score: 13.75

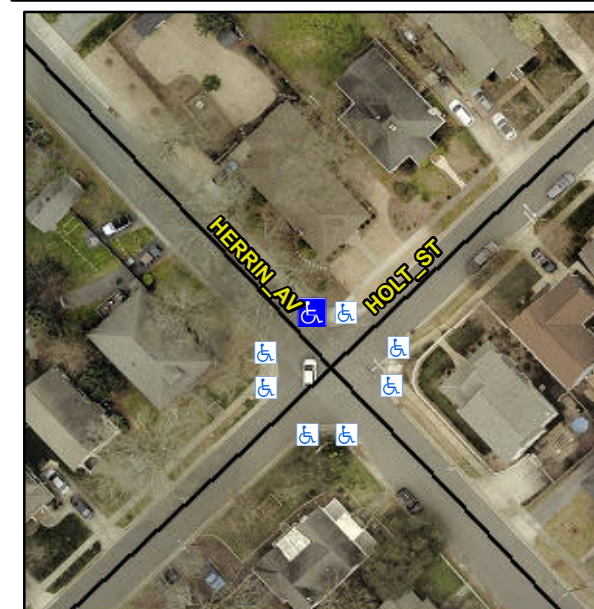
LT RP < 5%

Not Found, R304.3.2, R304.5.3

Compliance	Description	Data	Compliance	Description	Data
N/A	Ramp Length LT (in)	62.5	N/A	Ramp Length RT (in)	47.0
Yes	Ramp Width LT (in)	48.0	Yes	Ramp Width RT (in)	48.0
Yes	Ramp Slope LT (%)	1.5	No	Ramp Slope RT (%)	9.5
Yes	Ramp XSlope LT (%)	1.8	No	Ramp XSlope RT (%)	2.1
N/A	Ramp Length (in)	27.0	Yes	Ramp Slope (%)	6.6
Yes	Ramp Width (in)	48.0	Yes	Ramp XSlope (%)	2.6
N/A	Flare Type LT	N/A	N/A	Flare Type RT	N/A
N/A	Flare Slope LT (%)	N/A	N/A	Flare Slope RT (%)	N/A
N/A	Flare Traversable LT?	N/A	N/A	Flare Traversable RT?	N/A
N/A	Landing Length (in)	N/A	N/A	DWS Provided?	N/A
N/A	Landing Width (in)	N/A	N/A	DWS Contrast?	N/A
N/A	Landing Slope (%)	N/A	N/A	DWS Length (in)	N/A
N/A	Landing X Slope (%)	N/A	N/A	DWS Full Width?	N/A
N/A	Landing Curb? (Y/N)	N/A	N/A	DWS Offset (in)	N/A
N/A	Shared Landing?	N/A			
N/A	Gutter Ponding?	N/A	N/A	Gutter Slope (%)	N/A
N/A	Gutter Lip Ht (in)	N/A	N/A	Gutter X Slope (%)	N/A
N/A	Painted X Walk1?	No	N/A	Painted X Walk2?	N/A

Remove & Replace Entire Ramp.
