Access Compliance Report

Public Rights-of-Way

(Curb Ramps)

Intersection ID: 13045	Main Street: HAMORTON_PL	Cross Street: NANDINA_ST	Location: SW
ADA ID: 076381224828	Ramp Type: Perp	Initial Pass/Fail: Fail	Overall Compliance: No
Severity Score: 25			
Codes/Mitigation Info/Possible Solution		Field Measurements/Component Compliance

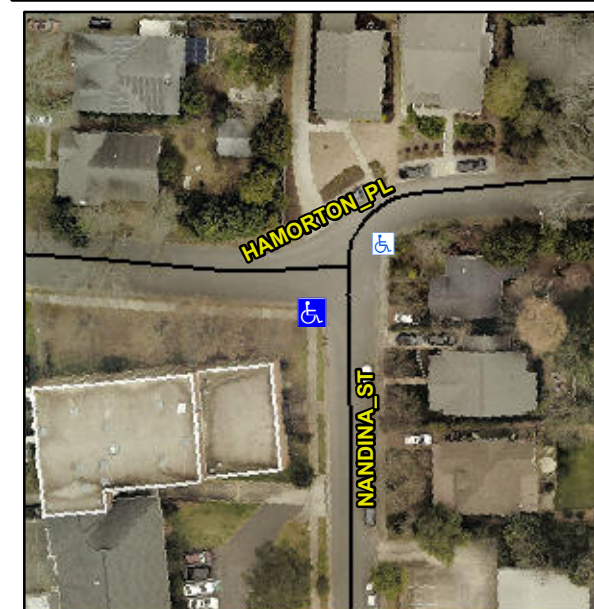
Not Found, R304.2.2, R304.5.3

Compliance	Description	Data	Compliance	Description	Data
N/A	Ramp Length (in)	29.0	No	Ramp Slope (%)	10.7
Yes	Ramp Width (in)	48.0	No	Ramp XSlope (%)	6.5
N/A	Flare Type LT	N/A	N/A	Flare Type RT	N/A
N/A	Flare Slope LT (%)	N/A	N/A	Flare Slope RT (%)	N/A
N/A	Flare Traversable LT?	N/A	N/A	Flare Traversable RT?	N/A
N/A	Landing Length (in)	N/A	N/A	DWS Provided?	N/A
N/A	Landing Width (in)	N/A	N/A	DWS Contrast?	N/A
N/A	Landing Slope (%)	N/A	N/A	DWS Length (in)	N/A
N/A	Landing X Slope (%)	N/A	N/A	DWS Full Width?	N/A
N/A	Landing Curb? (Y/N)	N/A	N/A	DWS Offset (in)	N/A
N/A	Shared Landing?	N/A			
N/A	Gutter Ponding?	N/A	N/A	Gutter Slope (%)	N/A
N/A	Gutter Lip Ht (in)	N/A	N/A	Gutter X Slope (%)	N/A
N/A	Painted X Walk1?	No	N/A	Painted X Walk2?	N/A
	X Walk 1 Direction	To E		X Walk 2 Direction	N/A
N/A	X Walk 1 Width (in)	N/A	N/A	X Walk 2 Width (in)	N/A
	X Walk 1 Slope (%)	1.5		X Walk 2 Slope (%)	N/A
	X Walk 1 X Slope (%)	4.4		X Walk 2 X Slope (%)	N/A

N/A	Ramp inside XWalk1?	N/A	N/A	Ramp inside XWalk2?	N/A
	Road Slope (%)	N/A	N/A	Clear Space?	N/A
	Road X Slope (%)	N/A	N/A	Clear Space to XWalk (in)	N/A
N/A	Any Obstructions?	N/A	N/A	Storm Grate/Utility Hazard?	N/A
	Obstruction Type			Storm Grate/Utility Type	
		N/A			N/A
		Yes		Surface Condition? (G/P)	Good

Remove & Replace Entire Ramp.
