Access Compliance Report

Public Rights-of-Way

(Curb Ramps)

Intersection ID: 18011	Main Street: PARK_RD	Cross Street: HEATHER_LN	Location: NW
ADA ID: 07D8F8F581C6	Ramp Type: Perp	Initial Pass/Fail: Fail	Overall Compliance: No
Severity Score: 46.25			
Codes/Mitigation Info/Possible Solution		Field Measurements/Component Compliance

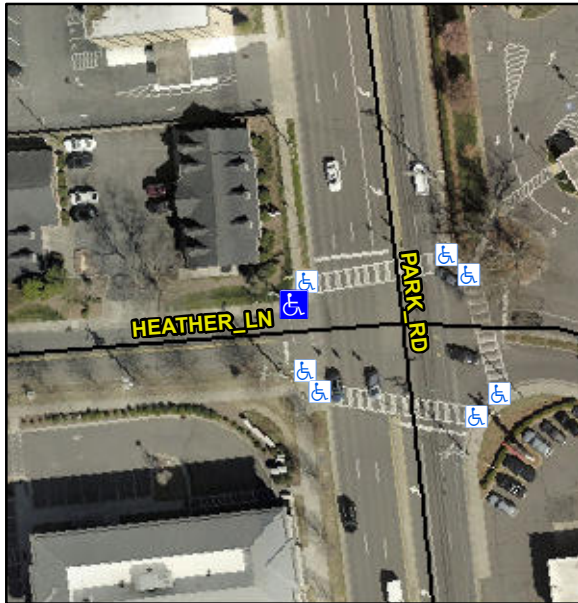
Not Found, R304.5.1, R304.2.2, R304.5.3

Compliance	Description	Data	Compliance	Description	Data
N/A	Ramp Length (in)	77.0	No	Ramp Slope (%)	10.3
No	Ramp Width (in)	46.0	No	Ramp XSlope (%)	9.6
N/A	Flare Type LT	N/A	N/A	Flare Type RT	N/A
N/A	Flare Slope LT (%)	N/A	N/A	Flare Slope RT (%)	N/A
N/A	Flare Traversable LT?	N/A	N/A	Flare Traversable RT?	N/A
N/A	Landing Length (in)	N/A	N/A	DWS Provided?	N/A
N/A	Landing Width (in)	N/A	N/A	DWS Contrast?	N/A
N/A	Landing Slope (%)	N/A	N/A	DWS Length (in)	N/A
N/A	Landing X Slope (%)	N/A	N/A	DWS Full Width?	N/A
N/A	Landing Curb? (Y/N)	N/A	N/A	DWS Offset (in)	N/A
N/A	Shared Landing?	N/A			
N/A	Gutter Ponding?	N/A	N/A	Gutter Slope (%)	N/A
N/A	Gutter Lip Ht (in)	N/A	N/A	Gutter X Slope (%)	N/A
N/A	Painted X Walk1?	No	N/A	Painted X Walk2?	N/A
	X Walk 1 Direction	To S		X Walk 2 Direction	N/A
N/A	X Walk 1 Width (in)	N/A	N/A	X Walk 2 Width (in)	N/A
	X Walk 1 Slope (%)	2.9		X Walk 2 Slope (%)	N/A
	X Walk 1 X Slope (%)	6.2		X Walk 2 X Slope (%)	N/A

Remove & Replace Entire Ramp.
