# Access Compliance Report

## Public Rights-of-Way

### (Curb Ramps)

Intersection ID: 10030604	Main Street: LOMA_LINDA_LN	Cross Street: N/A	Location: W
ADA ID: 07F85F73DD7C	Ramp Type: Perp	Initial Pass/Fail: Fail	Overall Compliance: No
Severity Score: 13.75			
Codes/Mitigation Info/Possible Solution		Field Measurements/Component Compliance

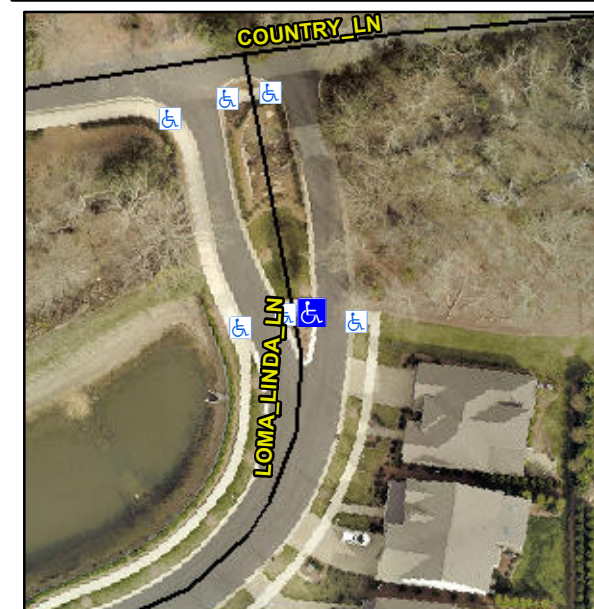
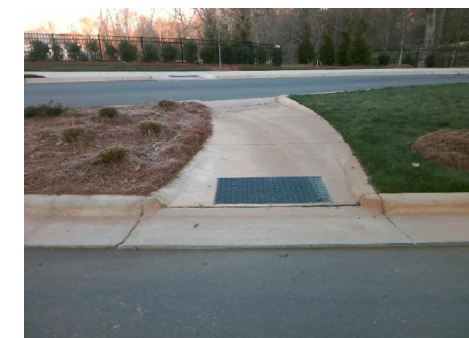
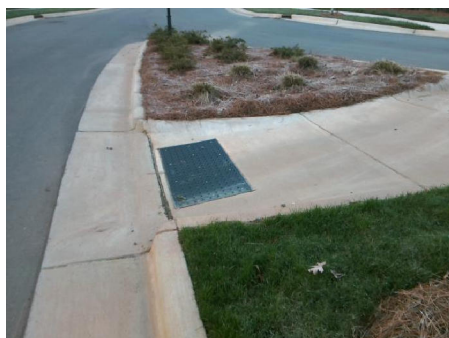
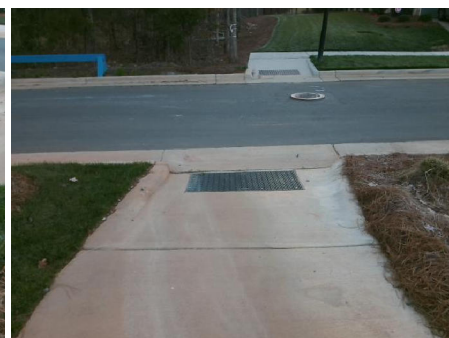
**Not Found, R304.2.2**

Compliance	Description	Data	Compliance	Description	Data
N/A	Ramp Length (in)	70.0	No	Ramp Slope (%)	11.6
Yes	Ramp Width (in)	68.0	Yes	Ramp XSlope (%)	3.0
N/A	Flare Type LT	N/A	N/A	Flare Type RT	N/A
N/A	Flare Slope LT (%)	N/A	N/A	Flare Slope RT (%)	N/A
N/A	Flare Traversable LT?	N/A	N/A	Flare Traversable RT?	N/A
N/A	Landing Length (in)	N/A	N/A	DWS Provided?	N/A
N/A	Landing Width (in)	N/A	N/A	DWS Contrast?	N/A
N/A	Landing Slope (%)	N/A	N/A	DWS Length (in)	N/A
N/A	Landing X Slope (%)	N/A	N/A	DWS Full Width?	N/A
N/A	Landing Curb? (Y/N)	N/A	N/A	DWS Offset (in)	N/A
N/A	Shared Landing?	N/A			
N/A	Gutter Ponding?	N/A	N/A	Gutter Slope (%)	N/A
N/A	Gutter Lip Ht (in)	N/A	N/A	Gutter X Slope (%)	N/A
N/A	Painted X Walk1?	No	N/A	Painted X Walk2?	N/A
	X Walk 1 Direction	To E		X Walk 2 Direction	N/A
N/A	X Walk 1 Width (in)	N/A	N/A	X Walk 2 Width (in)	N/A
	X Walk 1 Slope (%)	0.9		X Walk 2 Slope (%)	N/A
	X Walk 1 X Slope (%)	5.4		X Walk 2 X Slope (%)	N/A

**Remove & Replace Entire Ramp.**
