# Access Compliance Report

## Public Rights-of-Way

| Intersection ID: N/A | Main Street: LANCER_DR | Cross Street: LONDONTOWNE_DR | Location: NW |
| ADA ID: 084BB3776FD4 | Ramp Type: Perp | Initial Pass/Fail: Fail | Overall Compliance: No |

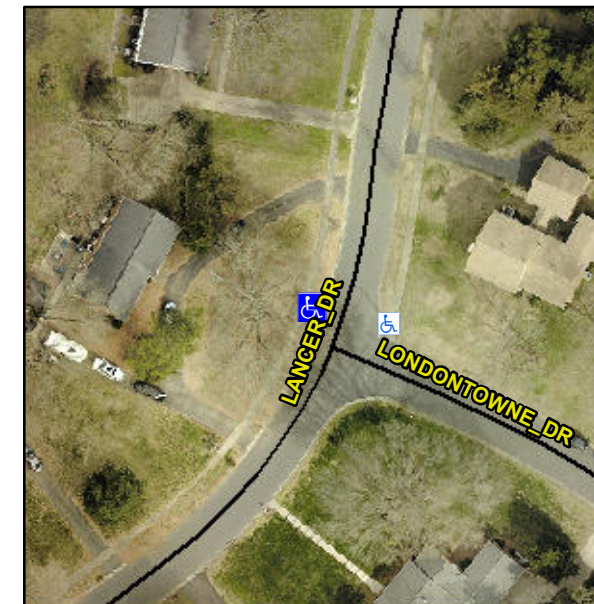
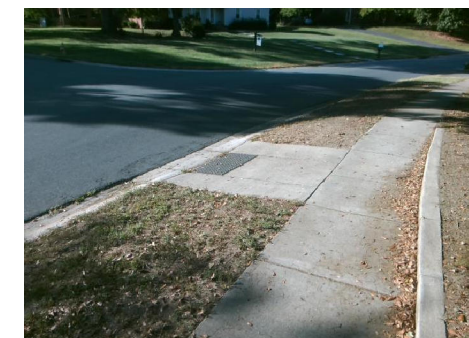
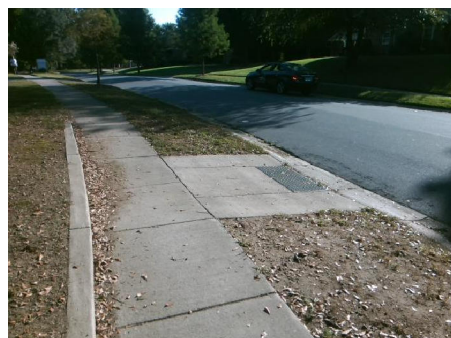
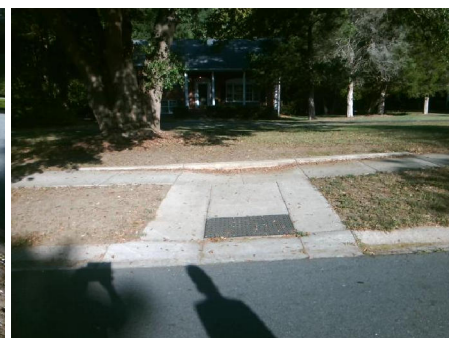
**R304.5.1, R304.2.2, R304.5.3**

| Compliance | Description | Data | Compliance | Description | Data |
|---|---|---|---|---|---|
| N/A | Ramp Length (in) | 83.0 | No | Ramp Slope (%) | 10.0 |
| No | Ramp Width (in) | 47.0 | No | Ramp XSlope (%) | 7.9 |

**Remove & Replace Entire Ramp.**
