Access Compliance Report

Public Rights-of-Way (Curb Ramps)

Intersection ID: 10485	Main Street: ANDERSON_ST	Cross Street: THE_PLAZA	Location:	S
ADA ID: 085187880DC3	Ramp Type: Combination1	Initial Pass/Fail: Fail	Overall Compliance: No	Severity Score: 67.5

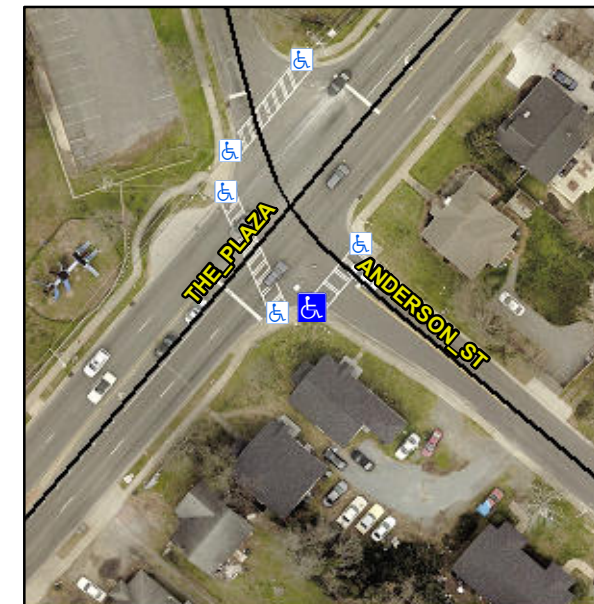
DAMAGED GTR, LT RP < 5%

**Not Found, R304.5.1, R304.5.1,
R304.5.3, R304.3.2**

Compliance	Description	Data	Compliance	Description	Data
N/A	Ramp Length LT (in)	54.5	N/A	Ramp Length RT (in)	55.5
No	Ramp Width LT (in)	35.0	No	Ramp Width RT (in)	40.0
Yes	Ramp Slope LT (%)	2.8	No	Ramp Slope RT (%)	12.5
Yes	Ramp XSlope LT (%)	1.9	Yes	Ramp XSlope RT (%)	1.7
N/A	Ramp Length (in)	28.0	Yes	Ramp Slope (%)	6.3
No	Ramp Width (in)	47.5	No	Ramp XSlope (%)	7.3
N/A	Flare Type LT	N/A	N/A	Flare Type RT	N/A
N/A	Flare Slope LT (%)	N/A	N/A	Flare Slope RT (%)	N/A
N/A	Flare Traversable LT?	N/A	N/A	Flare Traversable RT?	N/A
N/A	Landing Length (in)	N/A	N/A	DWS Provided?	N/A
N/A	Landing Width (in)	N/A	N/A	DWS Contrast?	N/A
N/A	Landing Slope (%)	N/A	N/A	DWS Length (in)	N/A
N/A	Landing X Slope (%)	N/A	N/A	DWS Full Width?	N/A
N/A	Landing Curb? (Y/N)	N/A	N/A	DWS Offset (in)	N/A
N/A	Shared Landing?	N/A			
N/A	Gutter Ponding?	N/A	N/A	Gutter Slope (%)	N/A
N/A	Gutter Lip Ht (in)	N/A	N/A	Gutter X Slope (%)	N/A
N/A	Painted X Walk1?	Yes	N/A	Painted X Walk2?	N/A

Remove & Replace Entire Ramp.
