Access Compliance Report Public Rights-of-Way (Curb Ramps)

Intersection ID: 12548 Main Street: E_MARTIN_LUTHER_KING_JR_CBVss Street: S_TRYON_ST Location: S

ADA ID: 08BDC07BE3FD Ramp Type: PerpDiag Initial Pass/Fail: Fail Overall Compliance: No Severity Score: 33.75

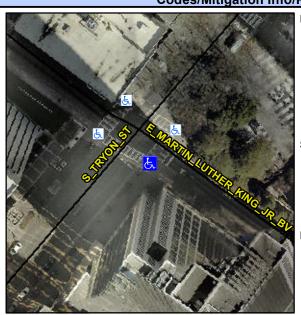
R304.5.1, R304.2.2, R304.5.3

| Compliance Description | | Data | Compliance Description | | Data |
|---|---|---|---|---|---|
| N/A | Ramp Length (in) | 77.0 | No | Ramp Slope (%) | 9.1 |
| No | Ramp Width (in) | 40.0 | No | Ramp XSlope (%) | 5.9 |

Remove & Replace Curb Ramp With Two New Directional Ramps or Equivalent.
