Access Compliance Report Public Rights-of-Way (Curb Ramps)

| Intersection ID: 10037598 | Main Street: SENECA_PL | Cross Street: N/A | Location: NW |
| ADA ID: 08DC3023A8ED | Ramp Type: ParaDiag | Initial Pass/Fail: Fail | Overall Compliance: No |

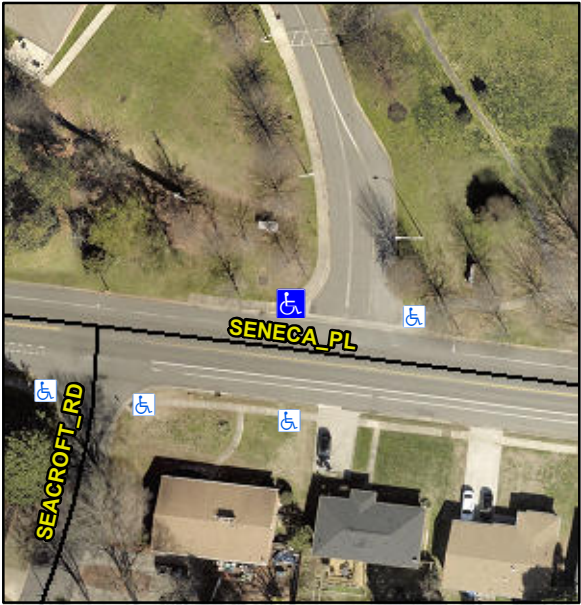
Surveyor Notes:
LT RP < 5%

PROW/ADA:
R304.3.2

| Compliance | Description | Data | Compliance | Description | Data |
|---|---|---|---|---|---|
| Yes | Ramp Slope LT (%) | 4.6 | No | Ramp Slope RT (%) | 13.9 |

Possible Solutions:
Remove & Replace Curb Ramp With Two New Directional Ramps or Equivalent.
