# Access Compliance Report

## Public Rights-of-Way

### (Curb Ramps)

Intersection ID: N/A	Main Street: FREEDOM_DR	Cross Street: S_I-85_RA	Location: S
ADA ID: 08F4AD2832A2	Ramp Type: BlendTrans1	Initial Pass/Fail: Pass	Overall Compliance: No
			Severity Score: 10.25

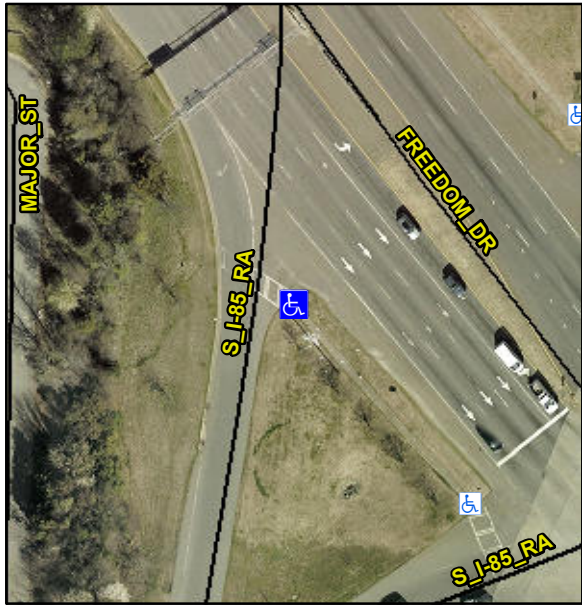
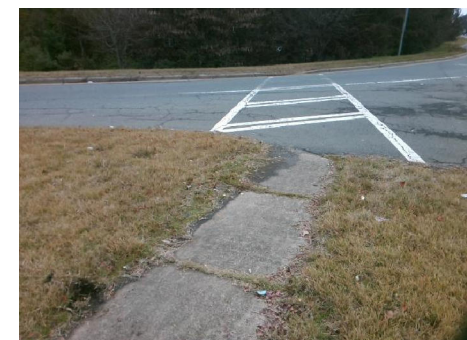
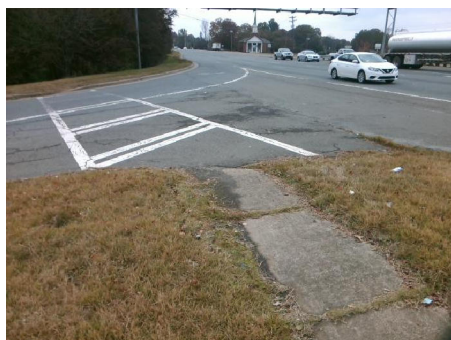
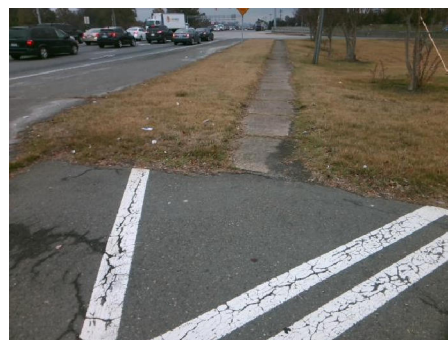
</div> <div>Street 1 NameS I-85 RA</div> <div>Stop Condition-Street 1None</div> <div>Street 2 NameN/A</div> <div>Stop Condition-Street 2N/A</div>		Possible Solutions:		Compliance		Description		Data	Compliance		Description		Data
		Install Detectable Warning System.		N/A	Ramp Length (in)	60.0	Yes	BlendTrans Slope (%)	0.8				
		Surveyor Notes:  LOCATED ON ISLAND		Yes	Ramp Width (in)	60.0	Yes	BlendTrans XSlope (%)	3.5				
				N/A	Flare Type LT	None	N/A	Flare Type RT	None				
				N/A	Flare Slope LT (%)	N/A	N/A	Flare Slope RT (%)	N/A				
				N/A	Flare Traversable LT?	N/A	N/A	Flare Traversable RT?	N/A				
				Yes	Landing Length (in)	60.0	No	DWS Provided?	No				
				Yes	Landing Width (in)	60.0	N/A	DWS Contrast?	No				
				Yes	Landing Slope (%)	0.3	N/A	DWS Length (in)	N/A				
				Yes	Landing X Slope (%)	4.8	N/A	DWS Full Width?	No

N/A	Landing Curb? (Y/N)	No	N/A	DWS Offset (in)	N/A				
				N/A	Shared Landing?	No							
		PROW/ADA:  R305		Yes	Gutter Ponding?	No	Yes	Gutter Slope (%)	2.7				
				Yes	Gutter Lip Ht (in)	0.0	Yes	Gutter X Slope (%)	3.4				
				N/A	Painted X Walk1?	Yes	N/A	Painted X Walk2?	N/A				
					X Walk 1 Direction	To NW		X Walk 2 Direction	N/A				
					X Walk 1 Width (in)	111.5		X Walk 2 Width (in)	N/A				
					X Walk 1 Slope (%)	0.7		X Walk 2 Slope (%)	N/A				
					X Walk 1 X Slope (%)	4.9		X Walk 2 X Slope (%)	N/A				
				Yes	Ramp inside XWalk1?	Yes	N/A	Ramp inside XWalk2?	N/A				
					Road Slope (%)	4.9		Clear Space?	Yes				
					Road X Slope (%)	0.7	N/A	Clear Space to XWalk (in)	N/A				
		Total Cost: \$ 235.00		Yes	Any Obstructions?	No	Yes	Storm Grate/Utility Hazard?	No				
					Obstruction Type			Storm Grate/Utility Type					
						N/A			N/A				
							Yes	Surface Condition? (G/P)	Good				
							Yes	Curb Slope (%)	1.4
