Access Compliance Report

Public Rights-of-Way

(Curb Ramps)

Intersection ID: 26766	Main Street: SETON_HOUSE_LN	Cross Street: N/A	Location: SW
ADA ID: 0927D3DDD340	Ramp Type: Perp	Initial Pass/Fail: Fail	Overall Compliance: No
Severity Score: 8.75			
Codes/Mitigation Info/Possible Solution		Field Measurements/Component Compliance

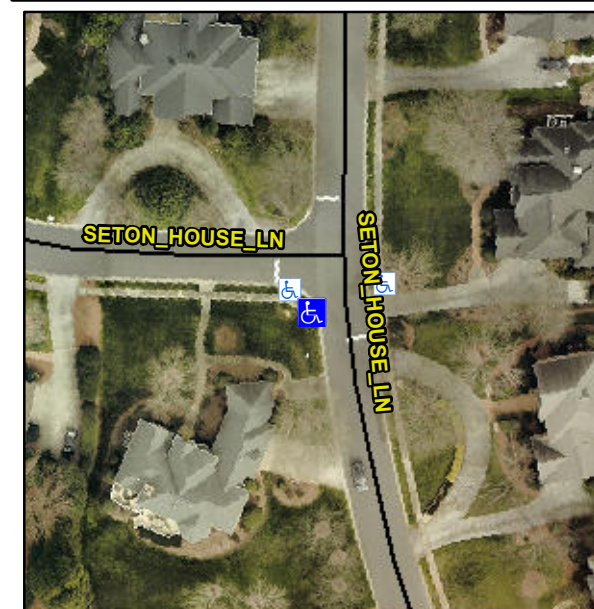
Not Found, R304.5.1

Compliance	Description	Data	Compliance	Description	Data
N/A	Ramp Length (in)	47.5	Yes	Ramp Slope (%)	7.1
No	Ramp Width (in)	36.5	Yes	Ramp XSlope (%)	0.3
N/A	Flare Type LT	N/A	N/A	Flare Type RT	N/A
N/A	Flare Slope LT (%)	N/A	N/A	Flare Slope RT (%)	N/A
N/A	Flare Traversable LT?	N/A	N/A	Flare Traversable RT?	N/A
N/A	Landing Length (in)	N/A	N/A	DWS Provided?	N/A
N/A	Landing Width (in)	N/A	N/A	DWS Contrast?	N/A
N/A	Landing Slope (%)	N/A	N/A	DWS Length (in)	N/A
N/A	Landing X Slope (%)	N/A	N/A	DWS Full Width?	N/A
N/A	Landing Curb? (Y/N)	N/A	N/A	DWS Offset (in)	N/A
N/A	Shared Landing?	N/A			
N/A	Gutter Ponding?	N/A	N/A	Gutter Slope (%)	N/A
N/A	Gutter Lip Ht (in)	N/A	N/A	Gutter X Slope (%)	N/A
N/A	Painted X Walk1?	No	N/A	Painted X Walk2?	N/A
	X Walk 1 Direction	To E		X Walk 2 Direction	N/A
N/A	X Walk 1 Width (in)	N/A	N/A	X Walk 2 Width (in)	N/A
	X Walk 1 Slope (%)	3.1		X Walk 2 Slope (%)	N/A
	X Walk 1 X Slope (%)	1.4		X Walk 2 X Slope (%)	N/A

N/A	Ramp inside XWalk1?	N/A	N/A	Ramp inside XWalk2?	N/A
	Road Slope (%)	N/A	N/A	Clear Space?	N/A
	Road X Slope (%)	N/A	N/A	Clear Space to XWalk (in)	N/A
N/A	Any Obstructions?	N/A	N/A	Storm Grate/Utility Hazard?	N/A
	Obstruction Type			Storm Grate/Utility Type	
		N/A			N/A
			Yes	Surface Condition? (G/P)	Good

Remove & Replace Entire Ramp.
