Access Compliance Report

Public Rights-of-Way

(Curb Ramps)

Intersection ID: 14278	Main Street: ROMARE_BEARDEN_DR	Cross Street: FARMER_ST	Location: S
ADA ID: 092E7F409439	Ramp Type: MedianPerp	Initial Pass/Fail: Fail	Overall Compliance: No
Severity Score: 1.25			
Codes/Mitigation Info/Possible Solution		Field Measurements/Component Compliance

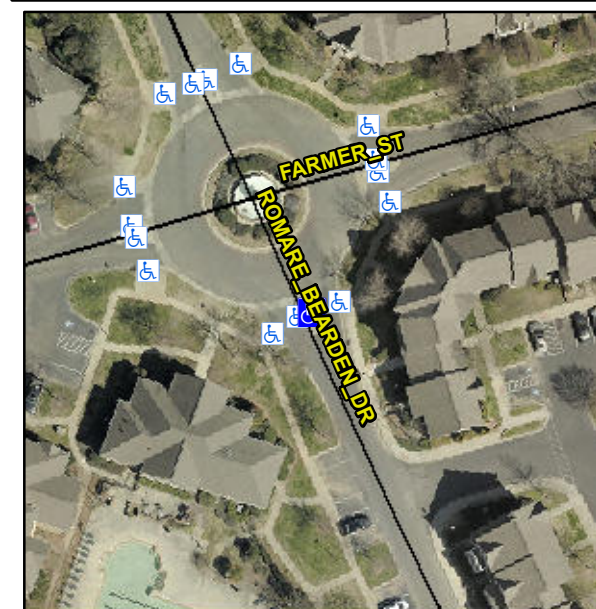
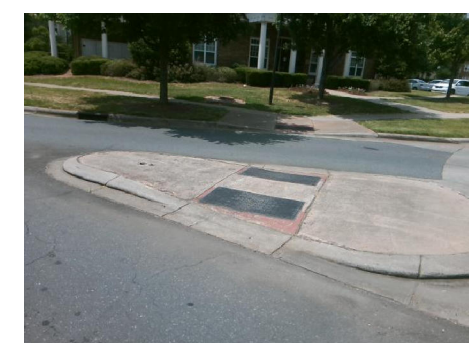
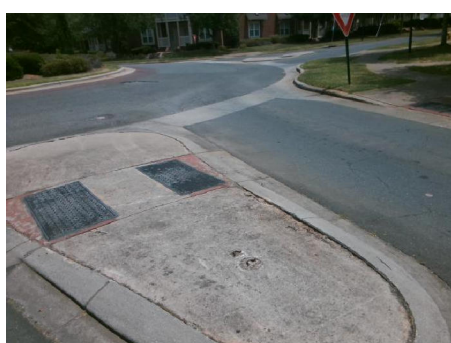
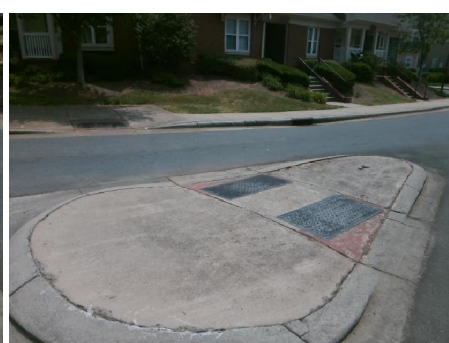
R304.5.3

Compliance	Description	Data	Compliance	Description	Data
N/A	Ramp Length (in)	43.0	Yes	Ramp Slope (%)	5.7
Yes	Ramp Width (in)	54.5	No	Ramp XSlope (%)	3.9
N/A	Flare Type LT	N/A	N/A	Flare Type RT	N/A
N/A	Flare Slope LT (%)	N/A	N/A	Flare Slope RT (%)	N/A
N/A	Flare Traversable LT?	N/A	N/A	Flare Traversable RT?	N/A
N/A	Landing Length (in)	N/A	N/A	DWS Provided?	N/A
N/A	Landing Width (in)	N/A	N/A	DWS Contrast?	N/A
N/A	Landing Slope (%)	N/A	N/A	DWS Length (in)	N/A
N/A	Landing X Slope (%)	N/A	N/A	DWS Full Width?	N/A
N/A	Landing Curb? (Y/N)	N/A	N/A	DWS Offset (in)	N/A
N/A	Shared Landing?	N/A			
N/A	Gutter Ponding?	N/A	N/A	Gutter Slope (%)	N/A
N/A	Gutter Lip Ht (in)	N/A	N/A	Gutter X Slope (%)	N/A
N/A	Painted X Walk1?	No	N/A	Painted X Walk2?	N/A
	X Walk 1 Direction	To E		X Walk 2 Direction	N/A
N/A	X Walk 1 Width (in)	N/A	N/A	X Walk 2 Width (in)	N/A
	X Walk 1 Slope (%)	0.1		X Walk 2 Slope (%)	N/A
	X Walk 1 X Slope (%)	2.2		X Walk 2 X Slope (%)	N/A

N/A	Ramp inside XWalk1?	N/A	N/A	Ramp inside XWalk2?	N/A
	Road Slope (%)	N/A	N/A	Clear Space?	N/A
	Road X Slope (%)	N/A	N/A	Clear Space to XWalk (in)	N/A
N/A	Any Obstructions?	N/A	N/A	Storm Grate/Utility Hazard?	N/A
	Obstruction Type			Storm Grate/Utility Type	
		N/A			N/A
			Yes	Surface Condition? (G/P)	Good

Remove & Replace Entire Ramp.
