# Access Compliance Report

## Public Rights-of-Way

### (Curb Ramps)

Intersection ID: 10541	Main Street: CANTON_PL	Cross Street: POLK_ST	Location: E
ADA ID: 099EB249DDAB	Ramp Type: Perp	Initial Pass/Fail: Fail	Overall Compliance: No
			Severity Score: 21.25

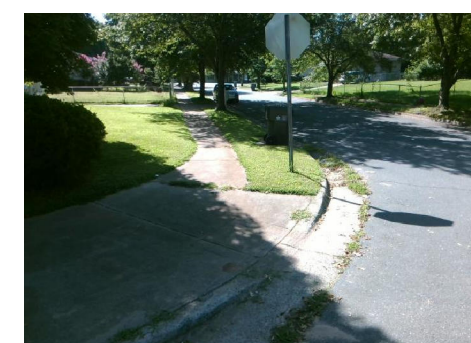
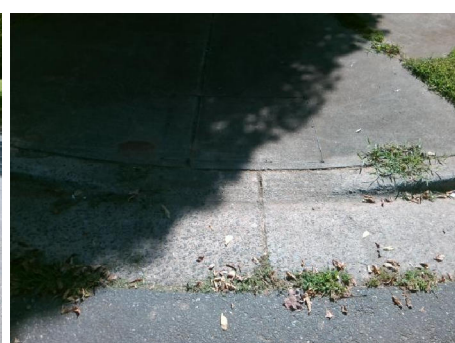
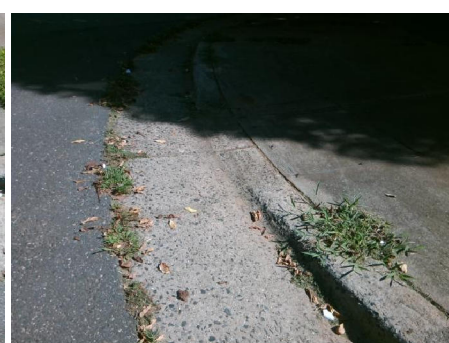
Possible Solutions:		<b>Compliance</b>	<b>Description</b>	<b>Data</b>
	<b>Remove &amp; Replace Entire Ramp.</b>		<b>No</b>	Ramp Length (in)	80.5
			<b>No</b>	Ramp Width (in)	47.0
			<b>N/A</b>	Flare Type LT	N/A
			<b>N/A</b>	Flare Slope LT (%)	N/A
			<b>N/A</b>	Flare Traversable LT?	N/A
			<b>N/A</b>	Landing Length (in)	N/A
			<b>N/A</b>	Landing Width (in)	N/A
			<b>N/A</b>	Landing Slope (%)	N/A
			<b>N/A</b>	Landing X Slope (%)	N/A
<p>Surveyor Notes:</p> <p><b>N/A</b></p> <p>PROW/ADA:</p> <p><b>Not Found, R304.5.1, R304.2.2</b></p>			<b>N/A</b>	Flare Type RT	N/A
			<b>N/A</b>	Flare Slope RT (%)	N/A
			<b>N/A</b>	Flare Traversable RT?	N/A
			<b>N/A</b>	DWS Provided?	N/A
			<b>N/A</b>	DWS Contrast?	N/A
			<b>N/A</b>	DWS Length (in)	N/A
			<b>N/A</b>	DWS Full Width?	N/A
			<b>N/A</b>	DWS Offset (in)	N/A
			<b>N/A</b>	Gutter Ponding?	N/A

<b>N/A</b>	Gutter Lip Ht (in)	0.5
			<b>No</b>	Painted X Walk1?	N/A
				X Walk 1 Direction	To SW
			<b>N/A</b>	X Walk 1 Width (in)	N/A
				X Walk 1 Slope (%)	2.1
				X Walk 1 X Slope (%)	1.3
			<b>N/A</b>	Ramp inside XWalk1?	N/A
			<b>N/A</b>	Road Slope (%)	N/A
			<b>N/A</b>	Road X Slope (%)	N/A
			<b>N/A</b>	Any Obstructions?	N/A
				Obstruction Type	
Total Cost: \$ 1850.00			<b>N/A</b>	Storm Grate/Utility Hazard?	N/A
				Storm Grate/Utility Type	
			<b>N/A</b>		N/A
			<b>Yes</b>	Surface Condition? (G/P)	Good
