Access Compliance Report

Public Rights-of-Way

(Curb Ramps)

Intersection ID: 14461	Main Street: E_WORTHINGTON_AV	Cross Street: LYNDHURST_AV	Location: S
ADA ID: 0A85A8339654	Ramp Type: Perp	Initial Pass/Fail: Fail	Overall Compliance: No
Severity Score: 12.5			
Codes/Mitigation Info/Possible Solution		Field Measurements/Component Compliance

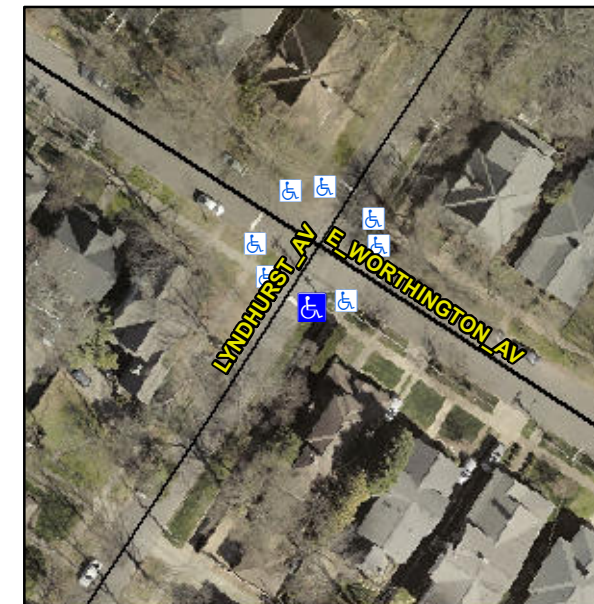
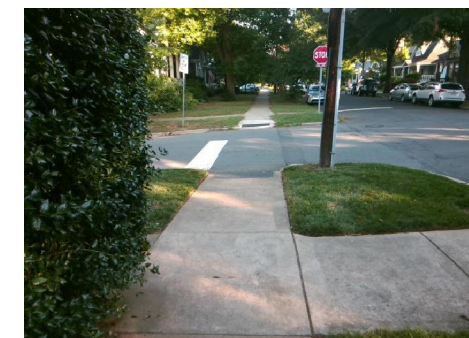
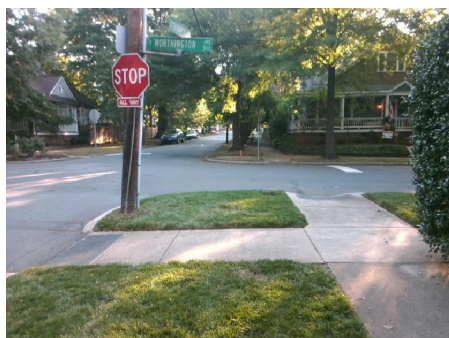
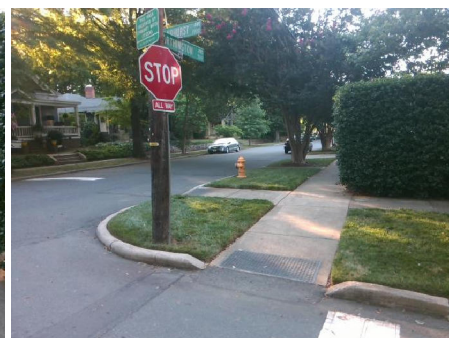
R304.5.3

Compliance	Description	Data	Compliance	Description	Data
N/A	Ramp Length (in)	136.0	Yes	Ramp Slope (%)	5.4
Yes	Ramp Width (in)	60.0	No	Ramp XSlope (%)	5.2
N/A	Flare Type LT	N/A	N/A	Flare Type RT	N/A
N/A	Flare Slope LT (%)	N/A	N/A	Flare Slope RT (%)	N/A
N/A	Flare Traversable LT?	N/A	N/A	Flare Traversable RT?	N/A
N/A	Landing Length (in)	N/A	N/A	DWS Provided?	N/A
N/A	Landing Width (in)	N/A	N/A	DWS Contrast?	N/A
N/A	Landing Slope (%)	N/A	N/A	DWS Length (in)	N/A
N/A	Landing X Slope (%)	N/A	N/A	DWS Full Width?	N/A
N/A	Landing Curb? (Y/N)	N/A	N/A	DWS Offset (in)	N/A
N/A	Shared Landing?	N/A			
N/A	Gutter Ponding?	N/A	N/A	Gutter Slope (%)	N/A
N/A	Gutter Lip Ht (in)	N/A	N/A	Gutter X Slope (%)	N/A
N/A	Painted X Walk1?	No	N/A	Painted X Walk2?	N/A
	X Walk 1 Direction	To NW		X Walk 2 Direction	N/A
N/A	X Walk 1 Width (in)	N/A	N/A	X Walk 2 Width (in)	N/A
	X Walk 1 Slope (%)	4.1		X Walk 2 Slope (%)	N/A
	X Walk 1 X Slope (%)	3.9		X Walk 2 X Slope (%)	N/A

N/A	Ramp inside XWalk1?	N/A	N/A	Ramp inside XWalk2?	N/A
	Road Slope (%)	N/A	N/A	Clear Space?	N/A
	Road X Slope (%)	N/A	N/A	Clear Space to XWalk (in)	N/A
N/A	Any Obstructions?	N/A	N/A	Storm Grate/Utility Hazard?	N/A
	Obstruction Type			Storm Grate/Utility Type	
		N/A			N/A
		Yes		Surface Condition? (G/P)	Good

Remove & Replace Entire Ramp.
