Access Compliance Report

Public Rights-of-Way

| Intersection ID: 10034320 | Main Street: PERIMETER_PY | Cross Street: N/A | Location: NE |
| ADA ID: 0AFC7D3C28BF | Ramp Type: Perp | Initial Pass/Fail: Fail | Overall Compliance: No |

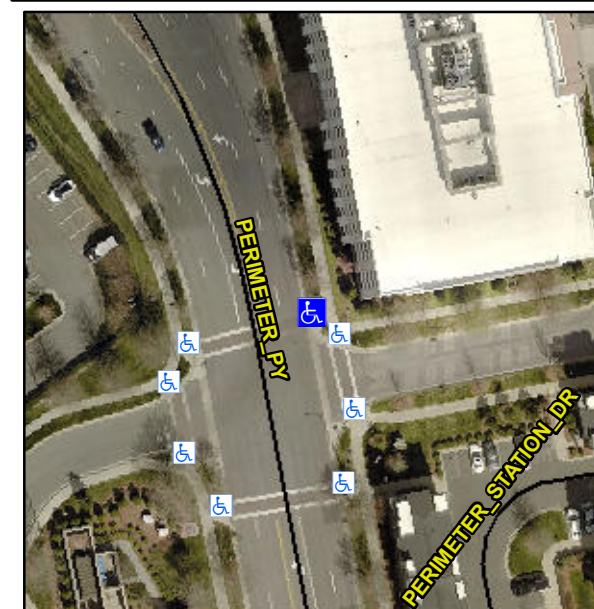
| Severity Score: 22.5 | | | |

Not Found, R304.5.1, R304.2.2

| Compliance | Description | Data | Compliance | Description | Data |
|---|---|---|---|---|---|
| N/A | Ramp Length (in) | 88.0 | No | Ramp Slope (%) | 8.7 |
| No | Ramp Width (in) | 47.0 | Yes | Ramp XSlope (%) | 2.4 |

Remove & Replace Entire Ramp.
