Access Compliance Report

Public Rights-of-Way

(Curb Ramps)

Intersection ID: 12498	Main Street: BELMONT_AV	Cross Street: LOUISE_AV	Location: W
ADA ID: 0B0106E0F7DC	Ramp Type: Perp	Initial Pass/Fail: Fail	Overall Compliance: No
Severity Score: 10			
Codes/Mitigation Info/Possible Solution		Field Measurements/Component Compliance

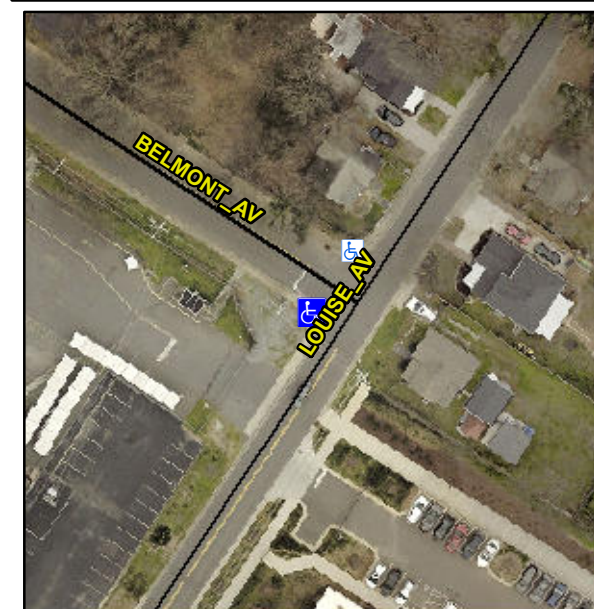
Not Found, R304.5.1, R304.5.3

Compliance	Description	Data	Compliance	Description	Data
N/A	Ramp Length (in)	42.0	Yes	Ramp Slope (%)	7.5
No	Ramp Width (in)	40.0	No	Ramp XSlope (%)	3.0
N/A	Flare Type LT	N/A	N/A	Flare Type RT	N/A
N/A	Flare Slope LT (%)	N/A	N/A	Flare Slope RT (%)	N/A
N/A	Flare Traversable LT?	N/A	N/A	Flare Traversable RT?	N/A
N/A	Landing Length (in)	N/A	N/A	DWS Provided?	N/A
N/A	Landing Width (in)	N/A	N/A	DWS Contrast?	N/A
N/A	Landing Slope (%)	N/A	N/A	DWS Length (in)	N/A
N/A	Landing X Slope (%)	N/A	N/A	DWS Full Width?	N/A
N/A	Landing Curb? (Y/N)	N/A	N/A	DWS Offset (in)	N/A
N/A	Shared Landing?	N/A			
N/A	Gutter Ponding?	N/A	N/A	Gutter Slope (%)	N/A
N/A	Gutter Lip Ht (in)	N/A	N/A	Gutter X Slope (%)	N/A
N/A	Painted X Walk1?	No	N/A	Painted X Walk2?	N/A
	X Walk 1 Direction	To NE		X Walk 2 Direction	N/A
N/A	X Walk 1 Width (in)	N/A	N/A	X Walk 2 Width (in)	N/A
	X Walk 1 Slope (%)	5.5		X Walk 2 Slope (%)	N/A
	X Walk 1 X Slope (%)	1.6		X Walk 2 X Slope (%)	N/A

Remove & Replace Entire Ramp.
