# Access Compliance Report

## Public Rights-of-Way

### (Curb Ramps)

Intersection ID: 26681	Main Street: COUNTRY_LN	Cross Street: LOMA_LINDA_LN	Location:	E
ADA ID: 0B4D7BAE4BA5	Ramp Type: MedianPerp	Initial Pass/Fail: Pass	Overall Compliance: No	Severity Score: 2.5

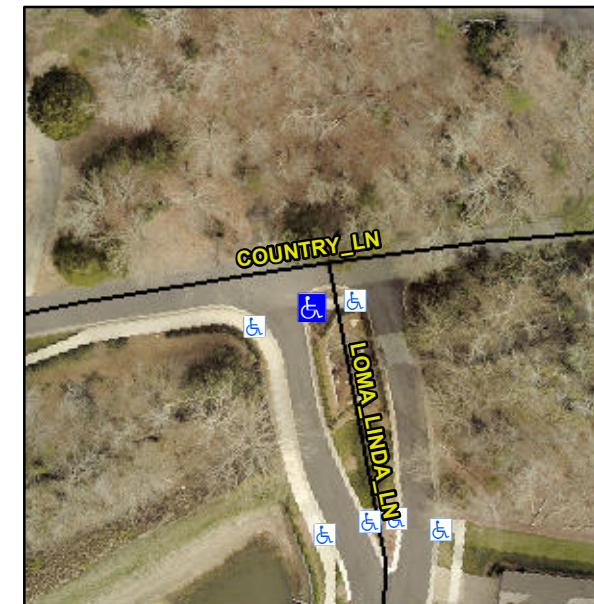
**Not Found, R304.2.1, R305.1.4, R305.2, R302.7**

Compliance	Description	Data	Compliance	Description	Data
N/A	Ramp Length (in)	48.0	Yes	Ramp Slope (%)	7.1
Yes	Ramp Width (in)	63.0	Yes	Ramp XSlope (%)	0.8
Yes	Flare Type LCurbed_NoWalkSurface		Yes	Flare Type RT	N/A
Yes	Flare Slope LT (%)	N/A	N/A	Flare Slope RT (%)	N/A
N/A	Flare Traversable LT?	No	N/A	Flare Traversable RT?	No
No	Landing Length (in)	27.0	Yes	DWS Provided?	Yes
Yes	Landing Width (in)	63.0	Yes	DWS Contrast?	Yes
Yes	Landing Slope (%)	0.8	Yes	DWS Length (in)	24.0
Yes	Landing X Slope (%)	1.5	No	DWS Full Width?	No
N/A	Landing Curb? (Y/N)	N/A	No	DWS Offset (in)	6.0
N/A	Shared Landing?	No			
No	Gutter Ponding?	Yes	Yes	Gutter Slope (%)	1.5
Yes	Gutter Lip Ht (in)	0.0	Yes	Gutter X Slope (%)	0.5
N/A	Painted X Walk1?	No	N/A	Painted X Walk2?	N/A
	X Walk 1 Direction	To W		X Walk 2 Direction	N/A
N/A	X Walk 1 Width (in)	N/A	N/A	X Walk 2 Width (in)	N/A
	X Walk 1 Slope (%)	0.0		X Walk 2 Slope (%)	N/A
	X Walk 1 X Slope (%)	0.4		X Walk 2 X Slope (%)	N/A

N/A	Ramp inside XWalk1?	N/A	N/A	Ramp inside XWalk2?	N/A
	Road Slope (%)	N/A	N/A	Clear Space?	Yes
	Road X Slope (%)	N/A	N/A	Clear Space to XWalk (in)	N/A
Yes	Any Obstructions?	No	Yes	Storm Grate/Utility Hazard?	No
	Obstruction Type			Storm Grate/Utility Type	
		N/A			N/A
			Yes	Surface Condition? (G/P)	Good

**Remove & Replace Entire Ramp.**
