# Access Compliance Report

## Public Rights-of-Way

### (Curb Ramps)

| Intersection ID: 9678 | Main Street: THE_PLAZA | Cross Street: VANDERBROOK_RD | Location: S |

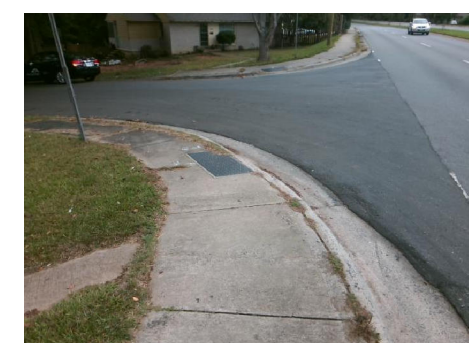
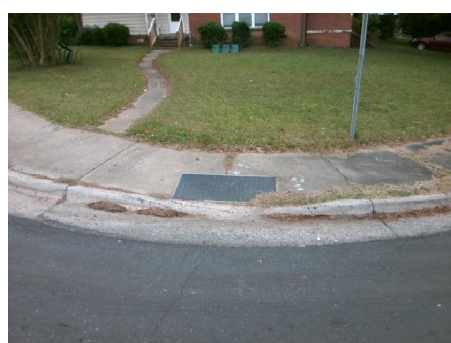
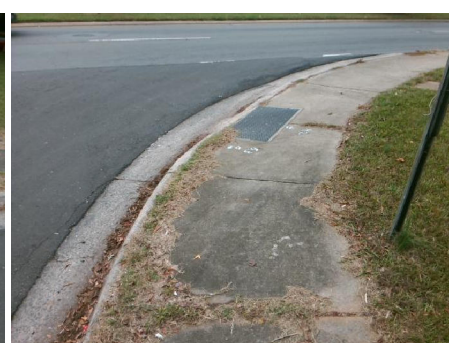
| ADA ID: 0C0F63C06DA8 | Ramp Type: Perp | Initial Pass/Fail: Fail | Overall Compliance: No |

**Not Found, R304.5.1, R304.5.3**

| Compliance | Description | Data | Compliance | Description | Data |
|---|---|---|---|---|---|
| N/A | Ramp Length (in) | 56.5 | Yes | Ramp Slope (%) | 7.0 |
| No | Ramp Width (in) | 47.0 | No | Ramp XSlope (%) | 4.2 |

**Remove & Replace Entire Ramp.**
